Building Analysis Report

Blacksburg, VA

Prepared For:
Sample Report

Inspection Date:
1/1/2019

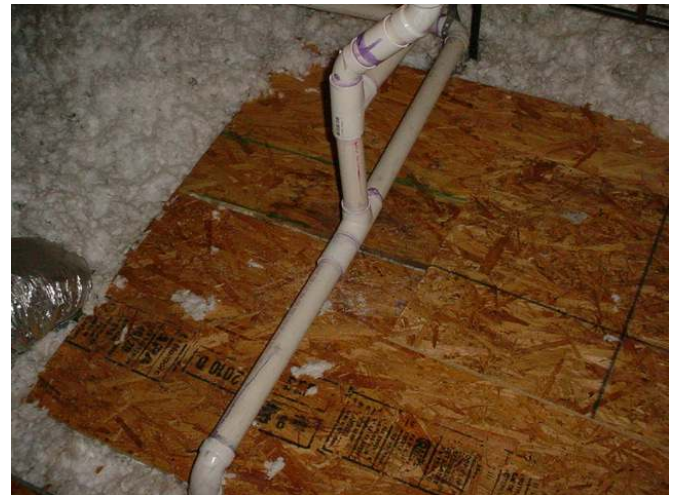
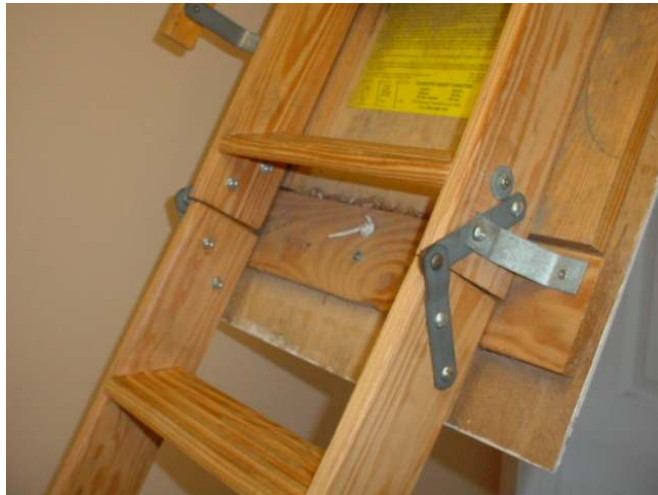
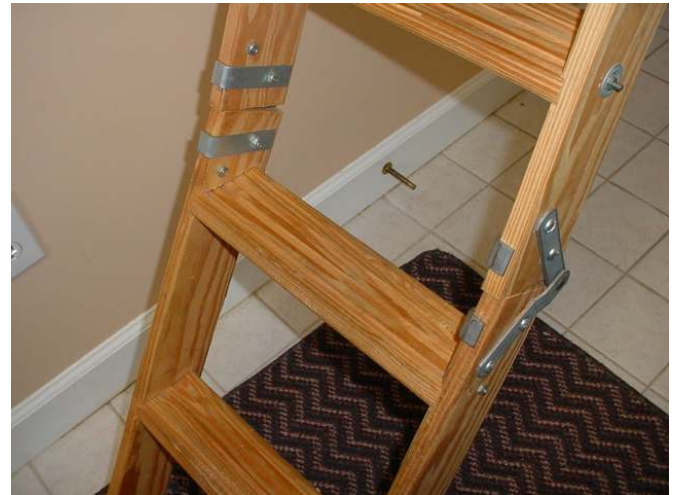
Evidence of Leaks

- **Monitor:** Stains on the OSB storage platform under the 2-inch PVC vent pipe indicate the flashing collar has leaked. The stain was dry at the time of inspection.

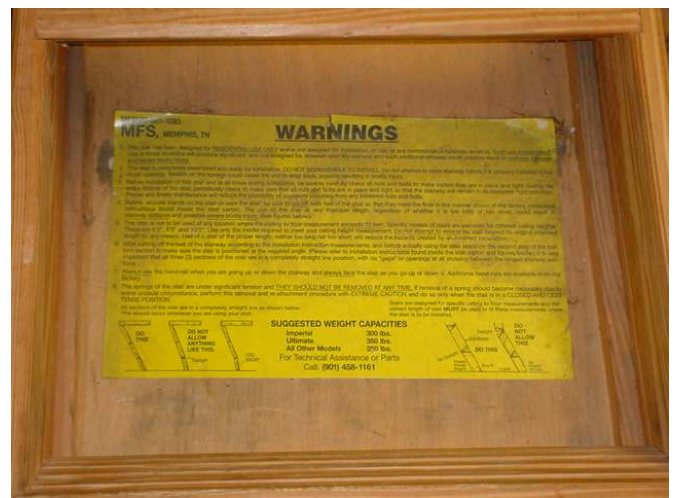
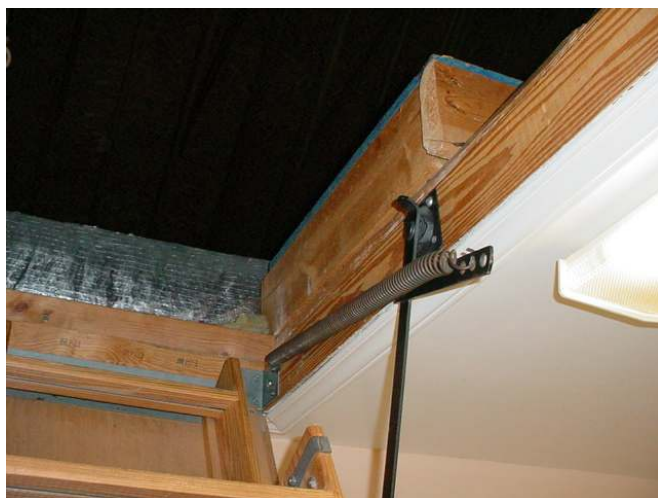
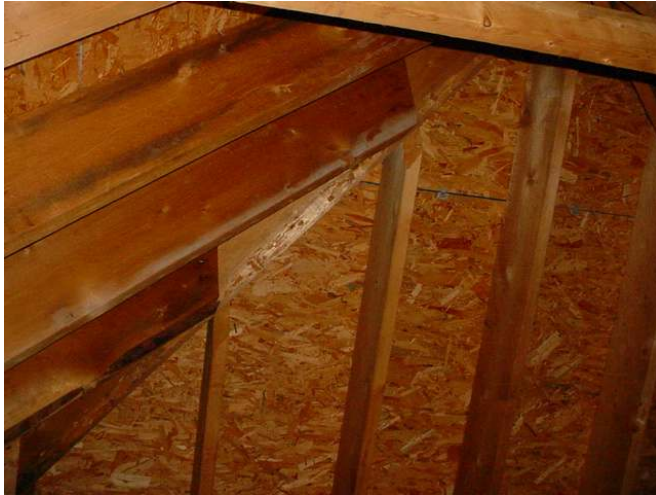
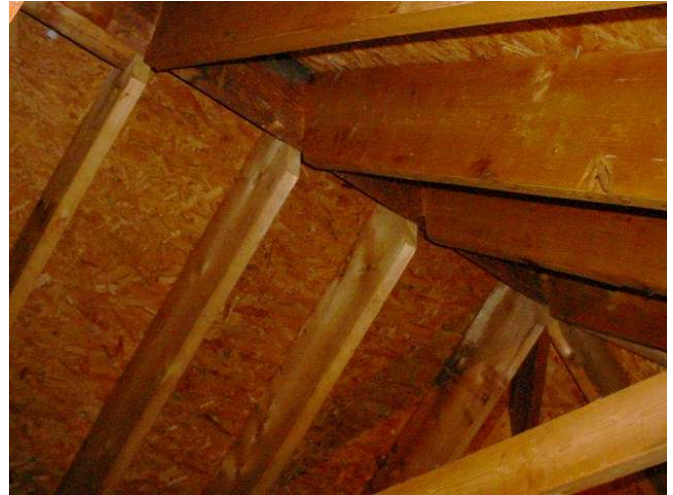
Access

- Repair: Safety Issue:** The pulldown ladder is too long, which prevents the side rails from closing tightly when the ladder is extended, and one of the support bracket connections is loose (image below), which allows the tension spring to become displaced from its guide. To maintain the integrity of the ladder, the hardware must remain secure, and the side rails must close tightly when the ladder is extended. Repair or replace the pulldown ladder.

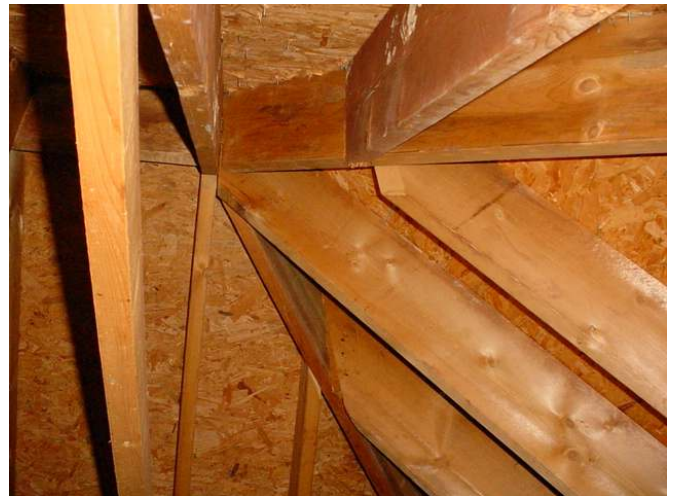
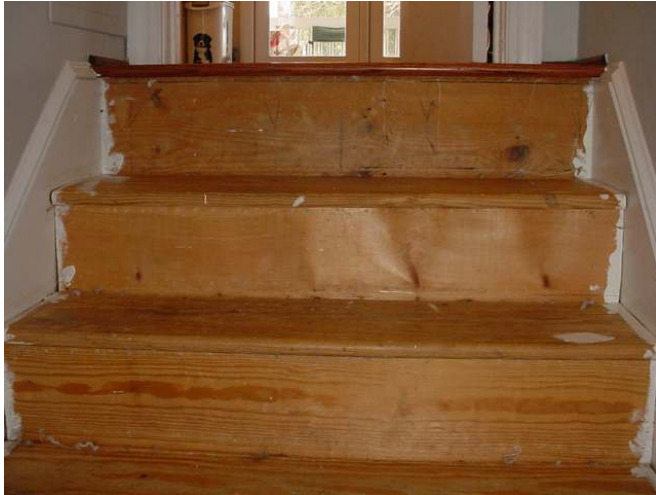
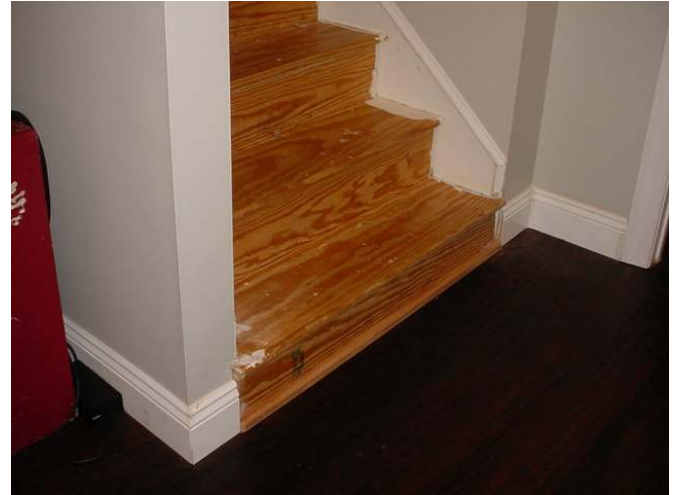
Roof Framing

- **Repair:** The common rafters hang below the ridge board, and the jack rafters hang below the hip rafters. The ridge board should be no less in depth than the cut end of the rafters. The hip rafters should be no less in depth than the cut end of the jack rafters.

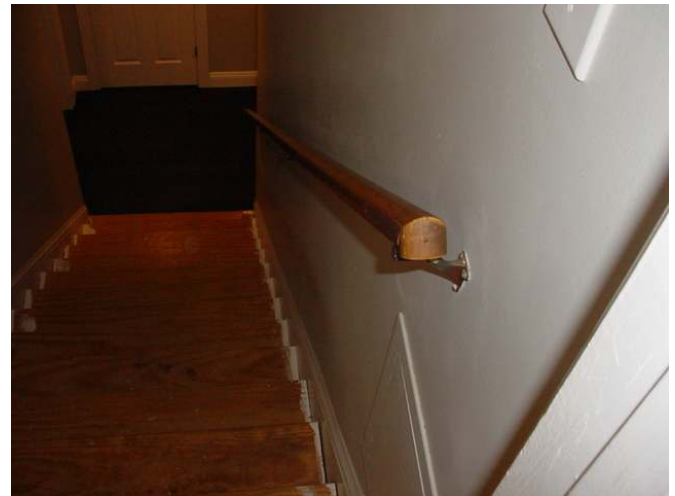
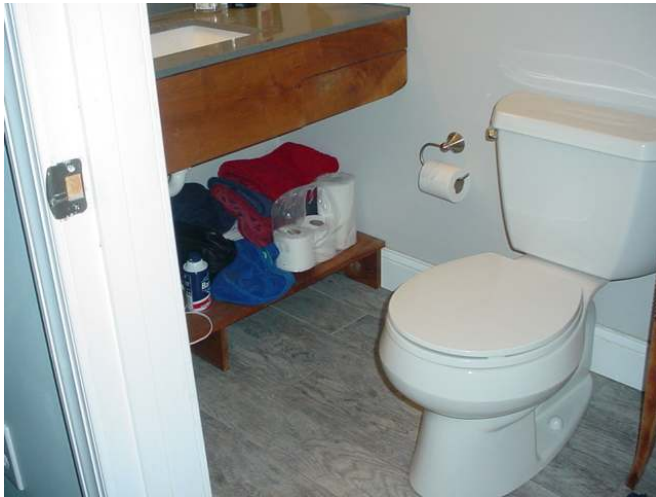
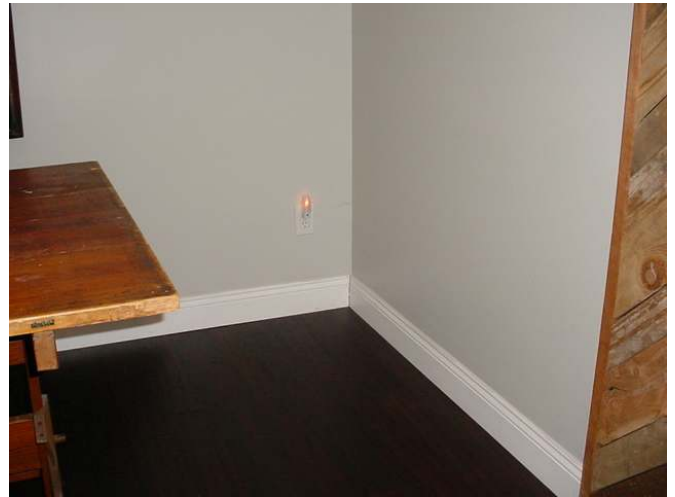
Stairway

- **Safety Issue:** The top step in the basement stairway is 9 inches tall, and the bottom step is 7 inches tall. Steps that are more than 8-1/4 inches tall, and steps in a stairway that vary in height more than 3/8-inch are tripping hazards.
- **Safety Issue:** The handrail is open-ended. Open handrails can catch purse straps and sleeves, which increases the risk of injury on a stairway. To eliminate this hazard, the ends of a handrail should return to the wall.

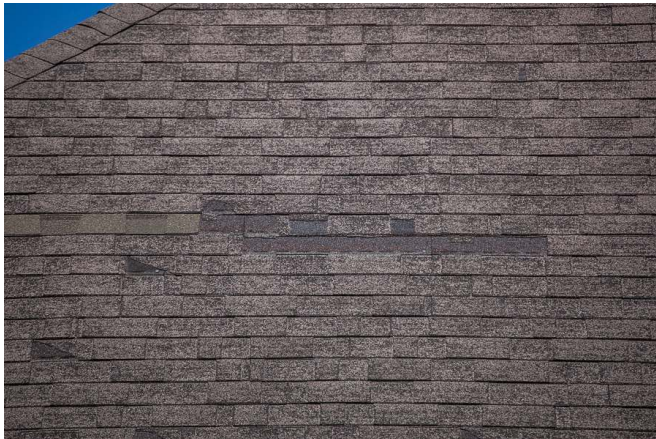
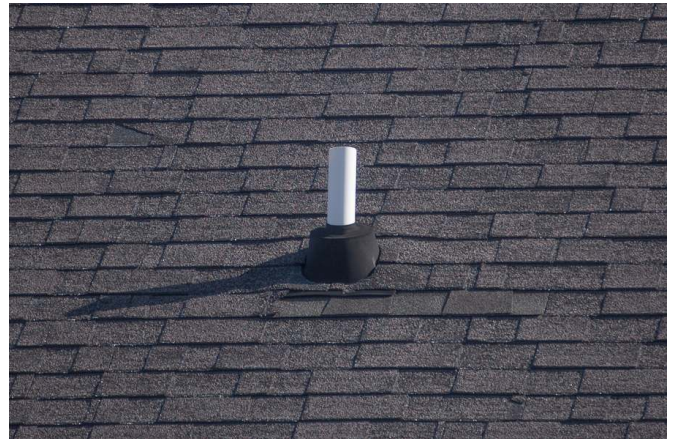
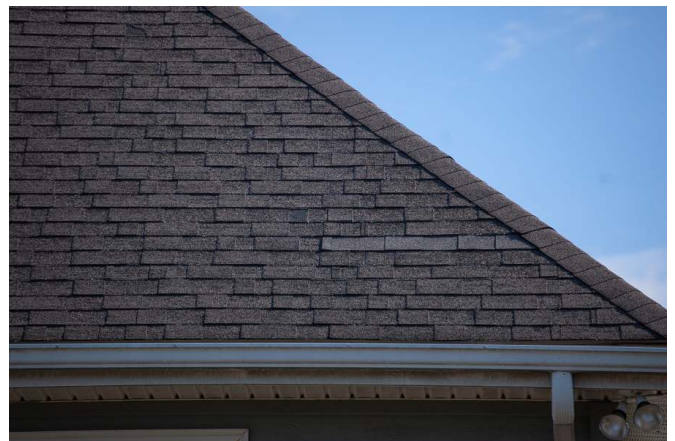
Roof Covering

- **Major Concern:** The shingles are worn and brittle, shingles and pieces of shingles are missing from the south exposure, and several shingles on the south and west exposures have been replaced, which indicates the roof covering is at the end of its reliable service life. Replacement of the roof covering is recommended.

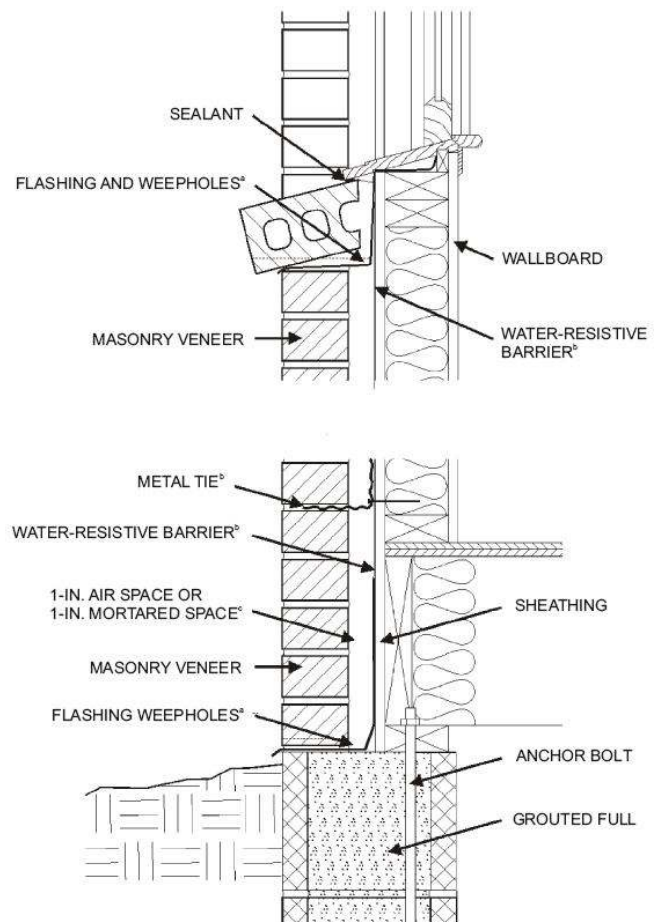
Exterior Walls

- There are no weep holes and no through-wall flashings in the brick veneer. Through-wall flashings collect moisture that has penetrated the brick veneer and divert it away from the wood-frame walls via the weep holes. Weep holes and through-wall flashings were specified in recent versions of the model building codes, but they were not required in local residential construction during the period of time in which this home was built.

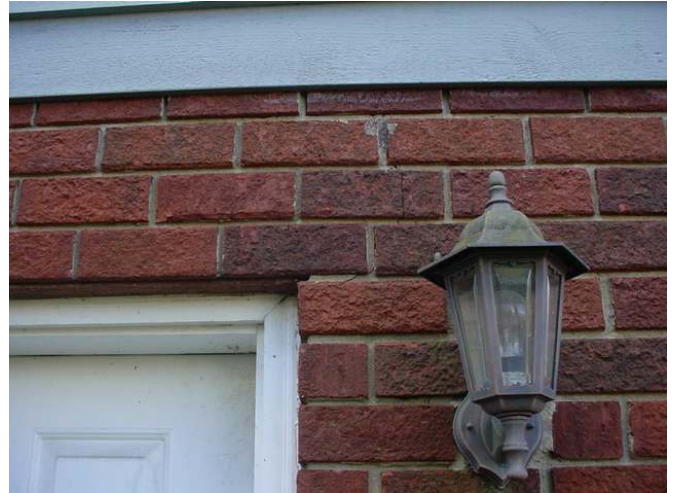
- A narrow crack in the brick veneer at the top of the basement doorway is typical of minor settlement.

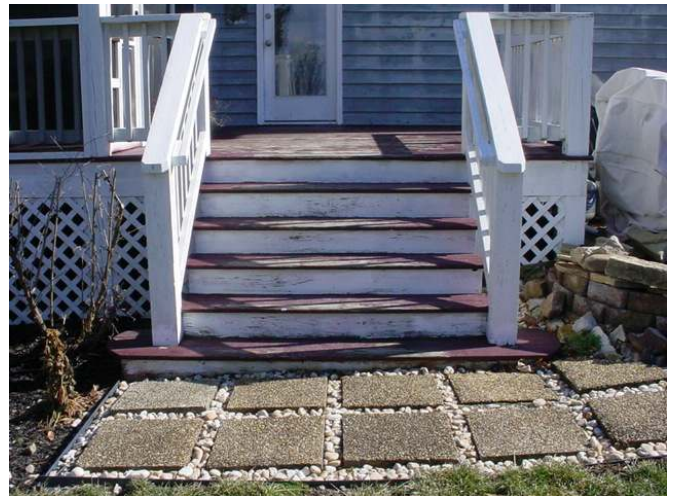
Deck

- **Safety Issue:** The bottom step in the deck stairway is short, which is a tripping hazard. Steps in a stairway that vary in height more than 3/8-inch are tripping hazards.

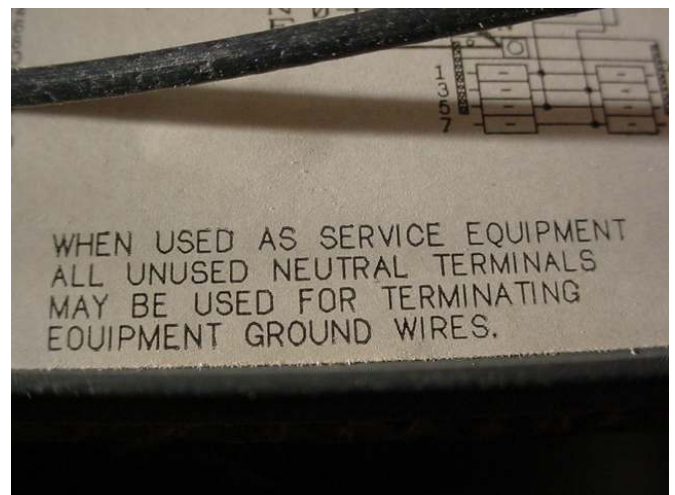
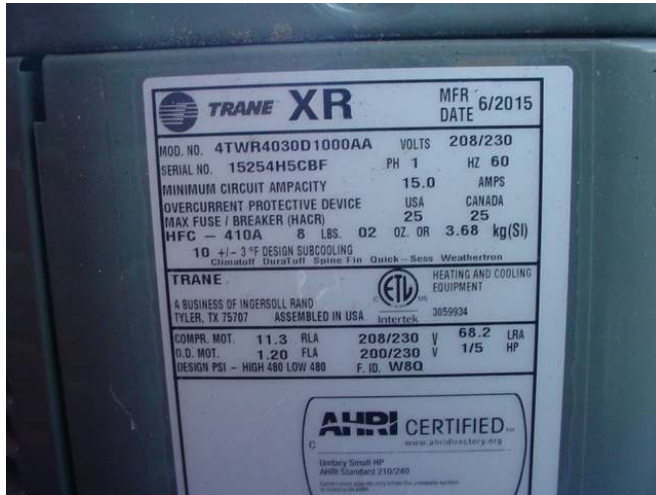
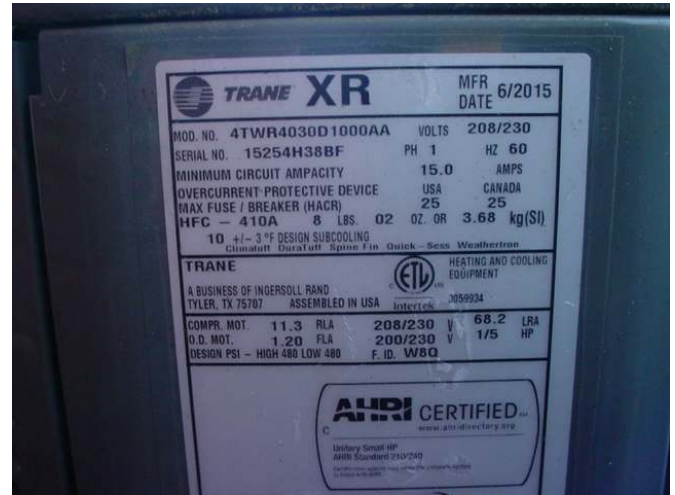
Main Panel

- **Safety Issue:** Several neutral bar terminals hold a neutral wire and an equipment grounding wire. According to the specifications on the panelbox label, only **unused** neutral branch terminals may be used as equipment grounding wire terminals. Multiple equipment grounding wires may connect to a single terminal, if the terminal is identified for connection of more than one conductor, but each neutral wire should connect to a terminal that is not used for another conductor.

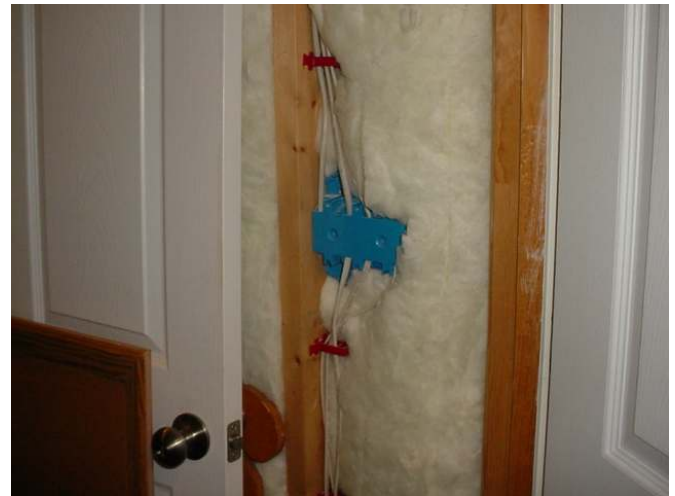
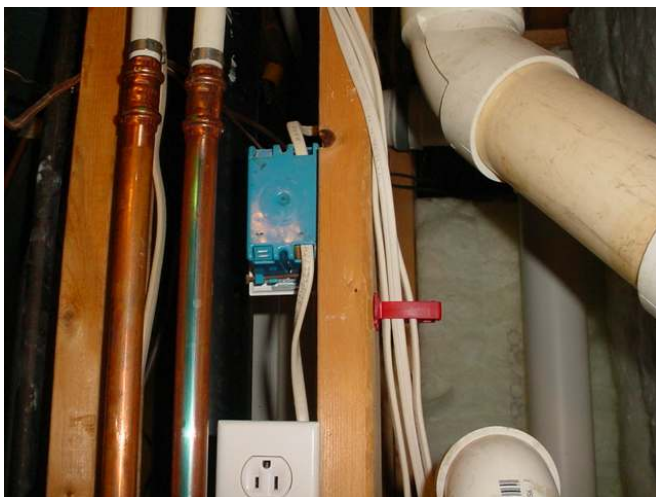
Distribution Wiring

- **Safety Issue:** Electrical cables are exposed in the basement mechanical room. Exposed wiring that is subject to physical damage should be adequately protected.
- **Safety Issue:** Several electrical cables in the basement mechanical room hang from plastic junction boxes. Any electrical cable that enters a single-gang plastic box should be stapled to the structure within 8 inches of the box to protect the wire connections from the stress of movement.

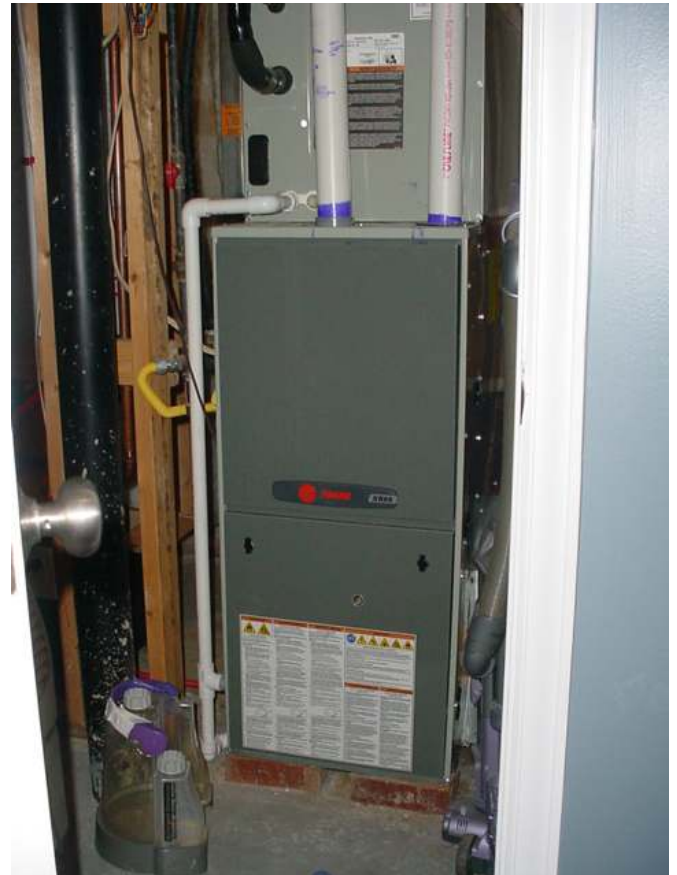
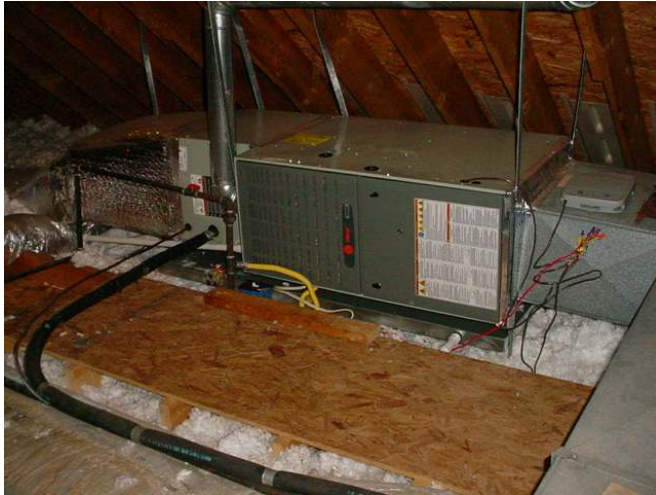
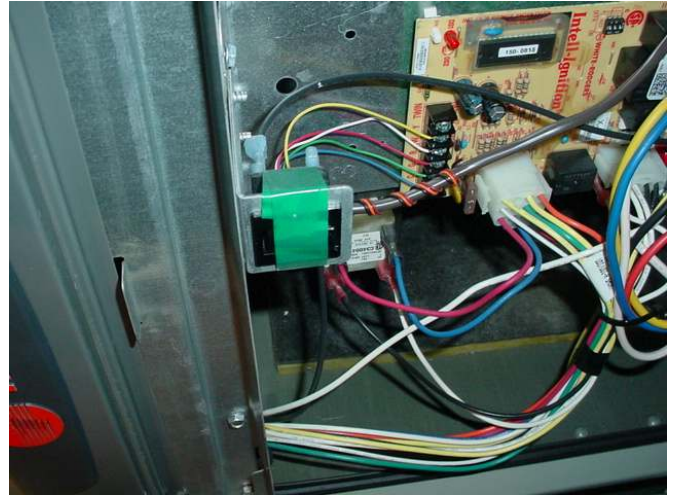
Main-Level Furnace

- The heating system functioned normally.
- **Repair: Safety Issue:** The flexible gas-appliance connector passes through the side wall of the furnace. According to the product labeling, appliance connectors should not be concealed within or extend through walls, floors or appliance panels.

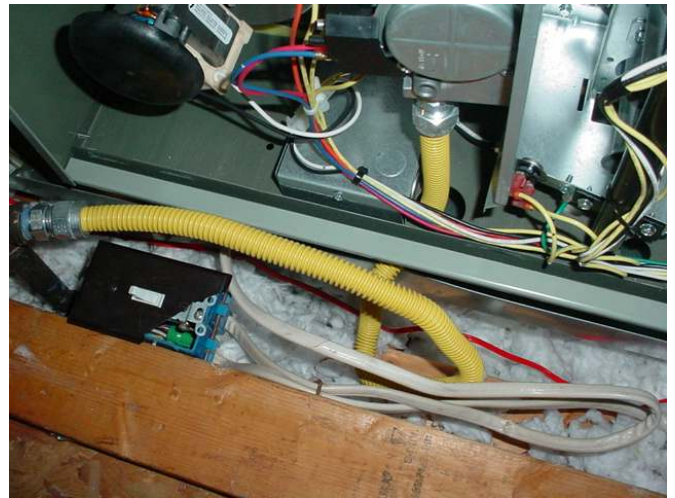
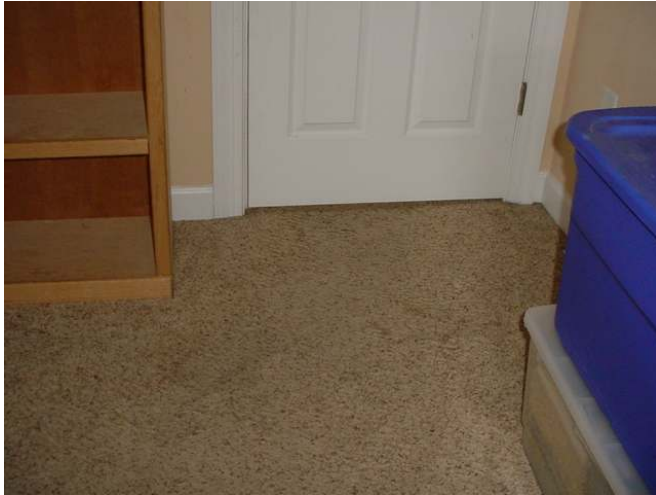
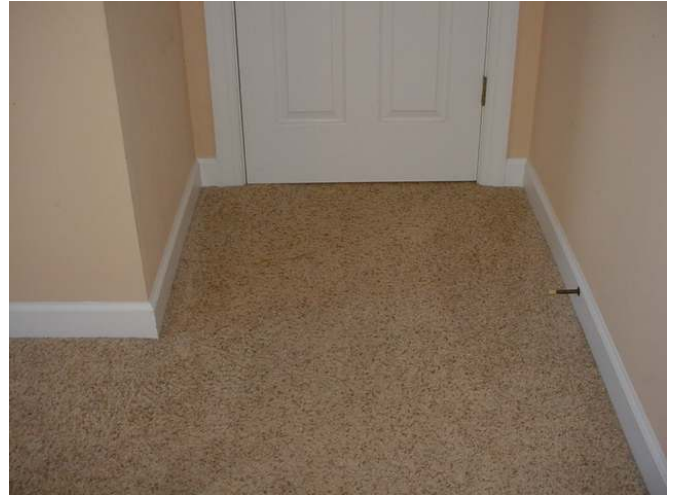
Upstairs Furnace

- The heating system functioned normally.
- **Repair: Safety Issue:** The switch at the blower compartment access panel (image above-right) has been secured in the 'closed' position with tape, which defeats its purpose. Repair as needed to allow the switch to kill power to the furnace when the panel is removed.
- **Repair: Safety Issue:** The flexible gas-appliance connector passes through the side wall of the furnace. According to the product labeling, appliance connectors should not be concealed within or extend through walls, floors or appliance panels.

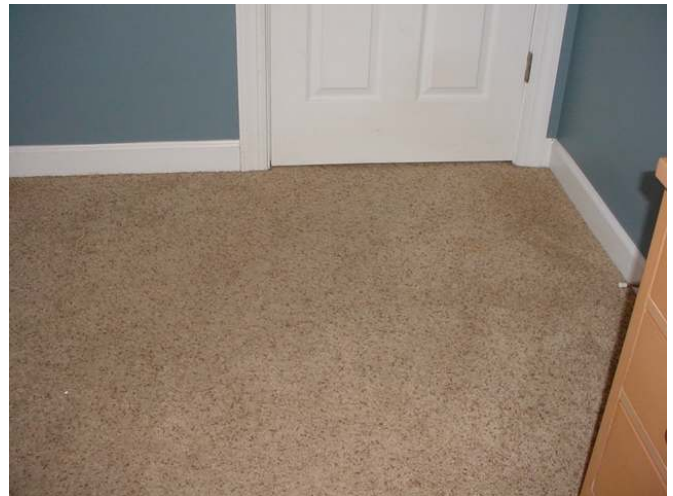
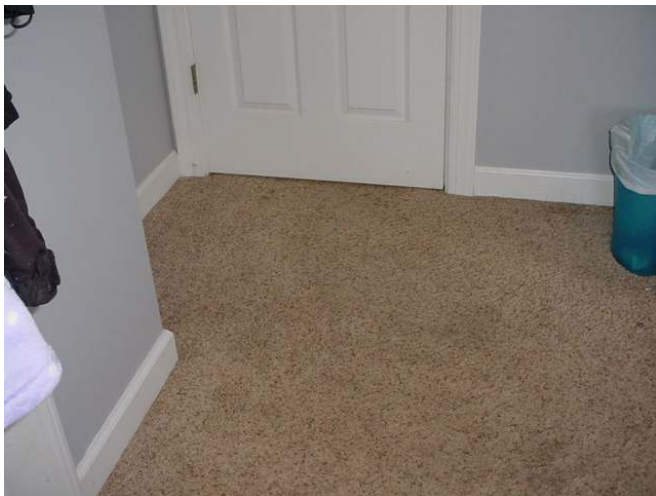
Return Air

- **Repair:** The narrow spaces under several of the interior doors restrict the flow of conditioned air back to the furnace. Undercut the doors as needed to improve air circulation and operating efficiency.

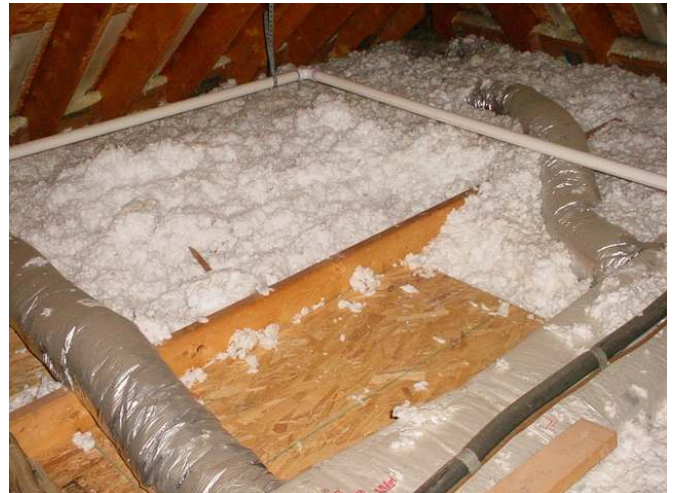
Attic / Roof

- **Improve:** Plywood panels have been installed on the ceiling joists, which compresses the ceiling insulation. To maintain the efficiency of the thermal barrier, flooring installed in an attic should be elevated above the design thickness of the ceiling insulation.

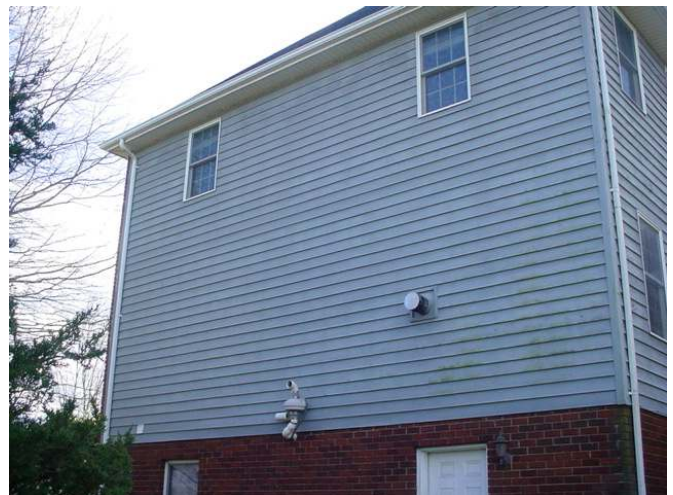
Radon Reduction System

- **Repair: Safety Issue:** The radon reduction system vent stack discharges horizontally below two windows. The discharge from vent stack pipes should be vertical and upward, outside the structure, at least 10 feet above the ground level, and above the edge of the roof. Whenever practicable, the vent stack should be above the highest roof of the building and above the highest ridge. The discharge from the vent stack should be ten feet or more away from any window, door, or other opening into conditioned or otherwise occupiable spaces of the structure, if the radon discharge point is not at least 2 feet above the top of such openings.

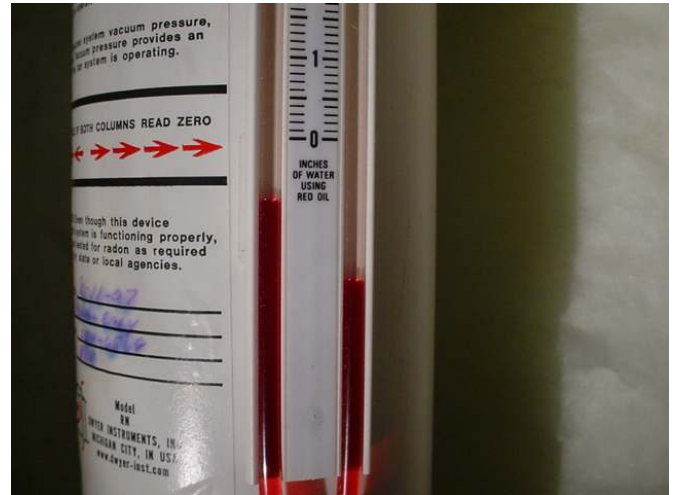
- **Repair:** The fluid level in the manometer is low. When the radon fan is off, the fluid level should be at zero on the scale.

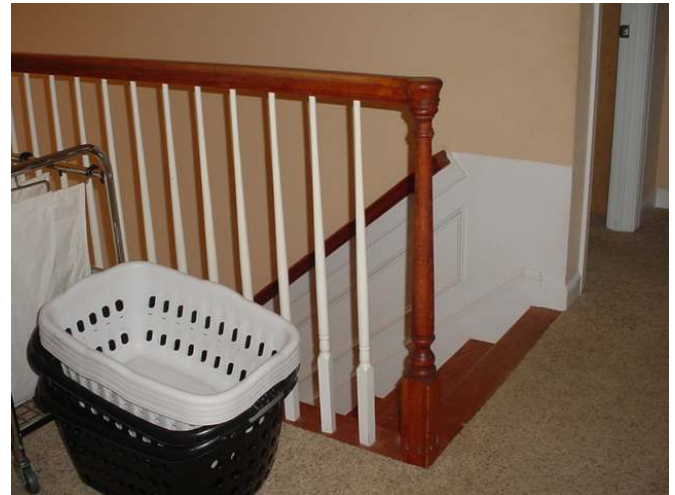
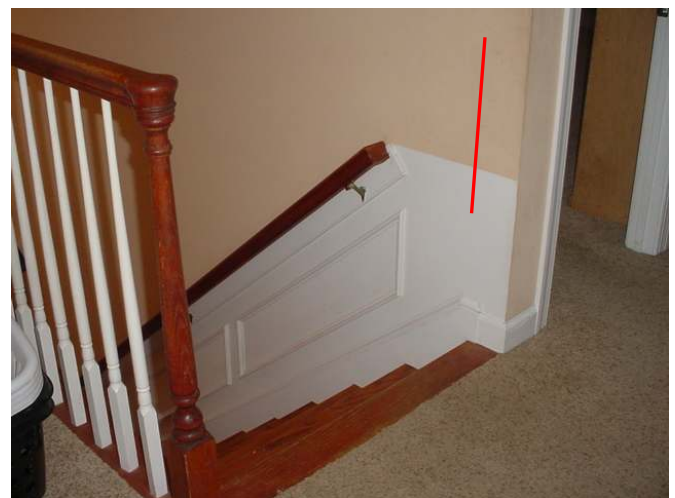
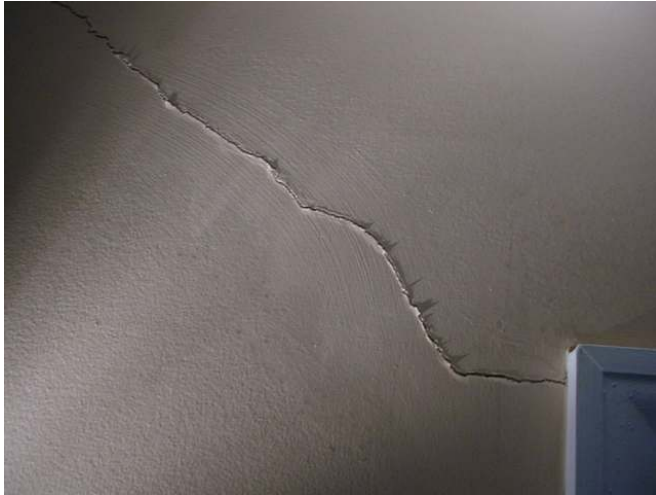
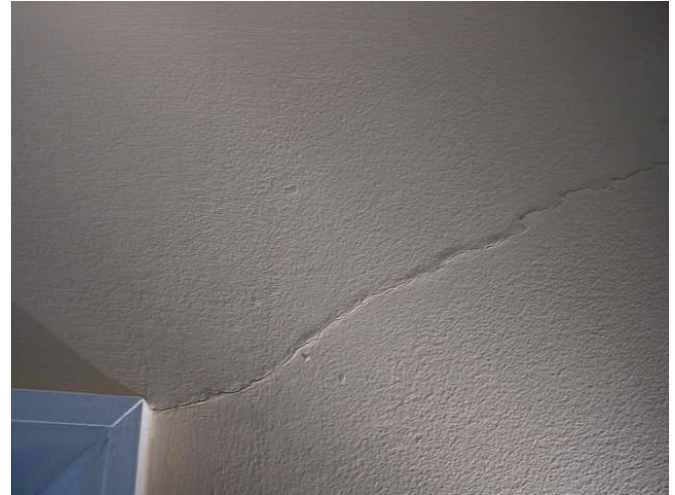
Stairway

- **Improve: Safety Issue:** The stairwell guard deflects when force is applied. Reinforce as needed to allow the guard to resist a single concentrated load of 200 pounds applied in any direction at any point along the top rail.
- **Repair: Safety Issue:** The handrail does not extend to the top step in the stairway. Handrails should be continuous for the full length of the flight, from a point directly above the top riser of the flight to a point directly above the lowest riser of the flight.

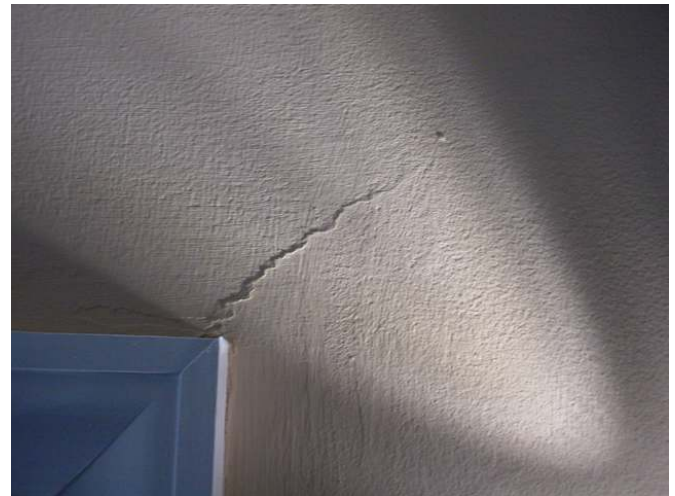
Wall Finishes

- **Monitor:** There are long stress cracks in the wall above the hall bathroom – bedroom doorway, and the door has been trimmed to clear the racked door jamb. The rough edges of the cracks are indicative of recent movement. Evaluation of the wall and review of the construction documents (if available) by a qualified contractor is recommended.
- The stress crack in the master bathroom wall (image right) is typical of minor thermal movement.

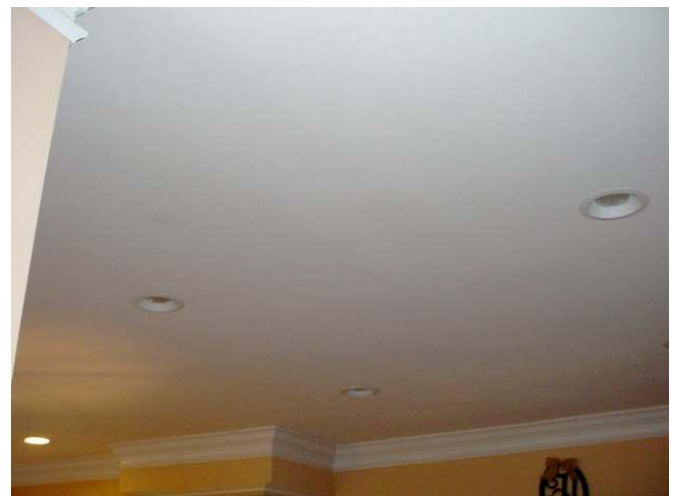
Ceiling Finishes

- A crack in a drywall panel joint in the great room ceiling is typical of minor thermal movement.

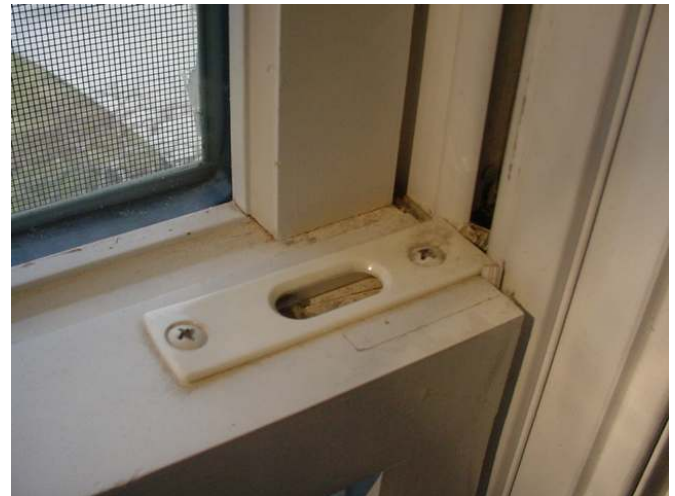
Windows

- **Repair:** Certain window sash guides in the master bedroom are missing or broken.

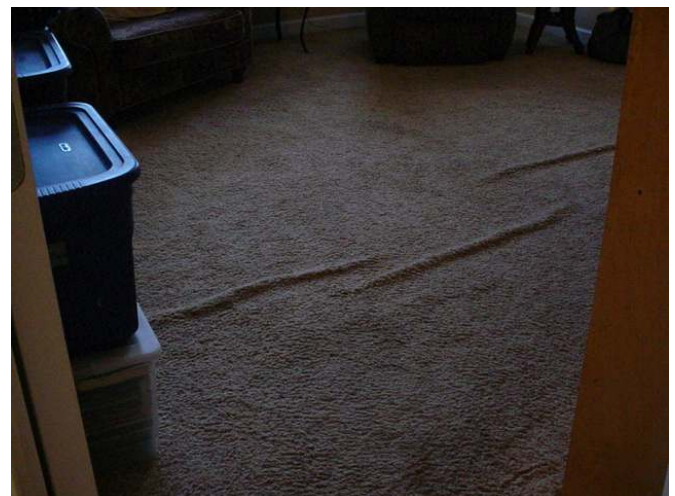
Floors

- **Repair:** The carpet in the master bedroom is wrinkled, which may become a tripping hazard.
