# Building Analysis Report

## Christiansburg, VA

Inspection Date:  
**5/6/2016**

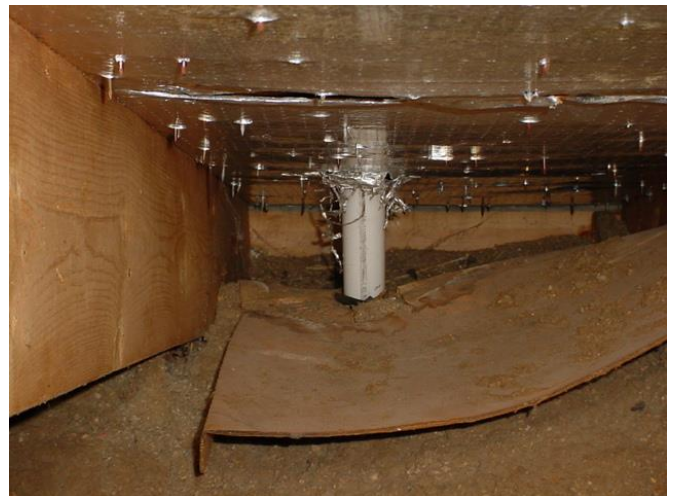
- **Repair:** Stains around the vent stack indicate the flashing collar on the roof has leaked.

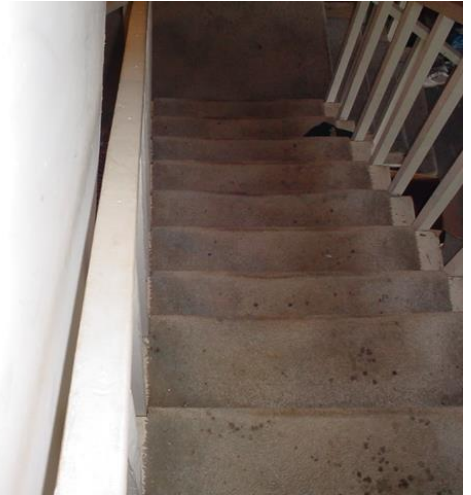
- **Safety Issue:** Clearance between one handrail and the wall is only 7/8-inch. To allow a handrail to be grasped safely, the clearance from the wall should be at least 1-1/2 inches.

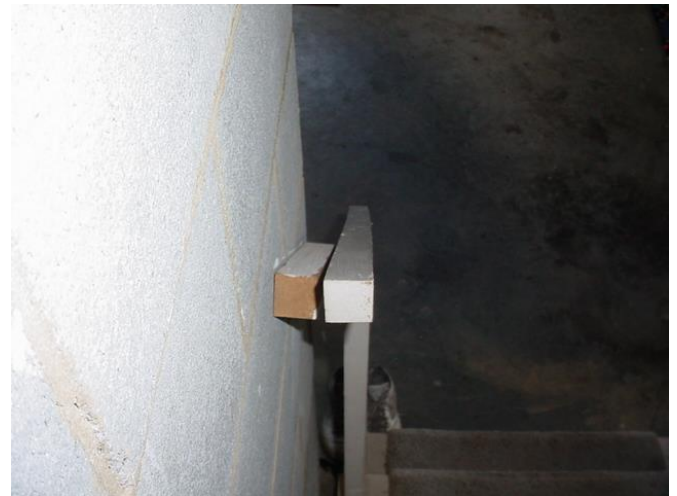
- **Safety Issue:** One handrail is open-ended. Open handrails can catch purse straps and sleeves, which increases the risk of injury on a stairway. To eliminate this hazard, the ends of a handrail should return to the wall.

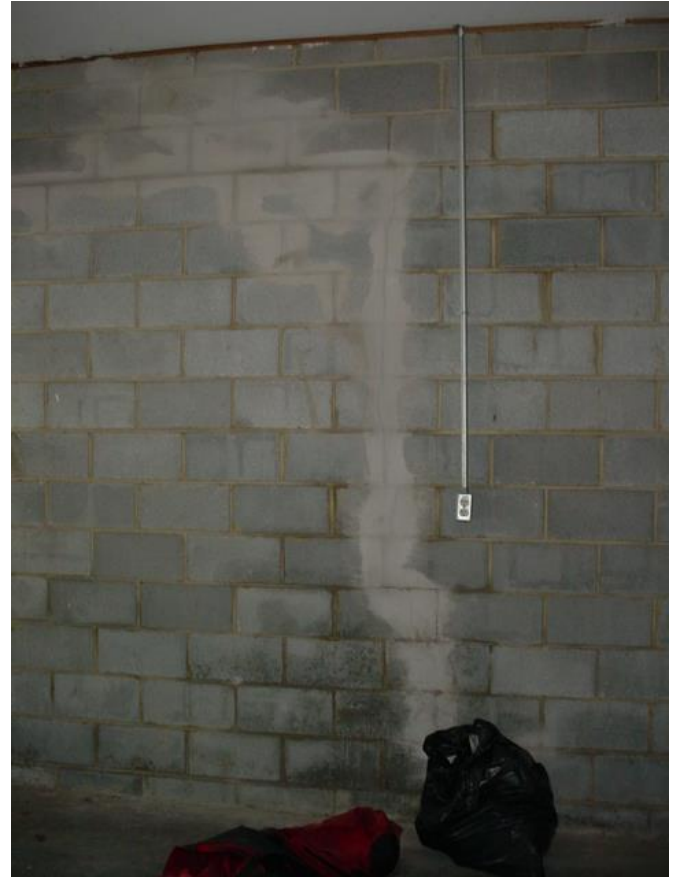
- An offset vertical crack in the front foundation wall is typical of settlement and lateral pressure exerted by saturated expansive soil. The crack has been patched. Reinforcement of the wall may be needed if movement continues.

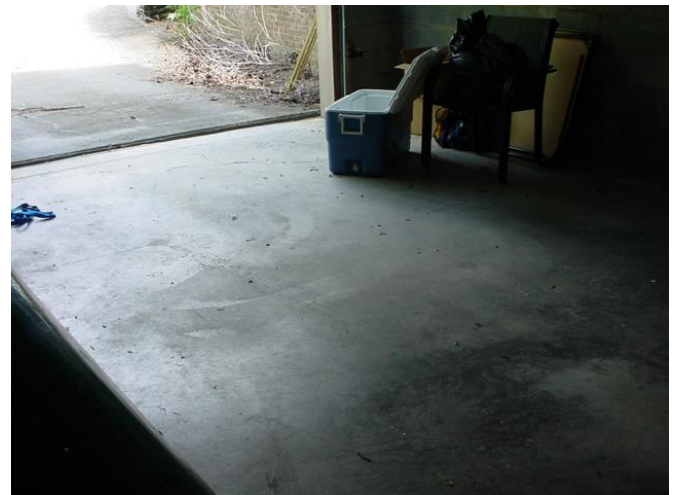
- **Safety Issue:** The garage floor appears to be relatively level. The area of floor used for parking automobiles or other vehicles should be sloped to facilitate the movement of liquids to a drain or toward the main vehicle entry doorway.

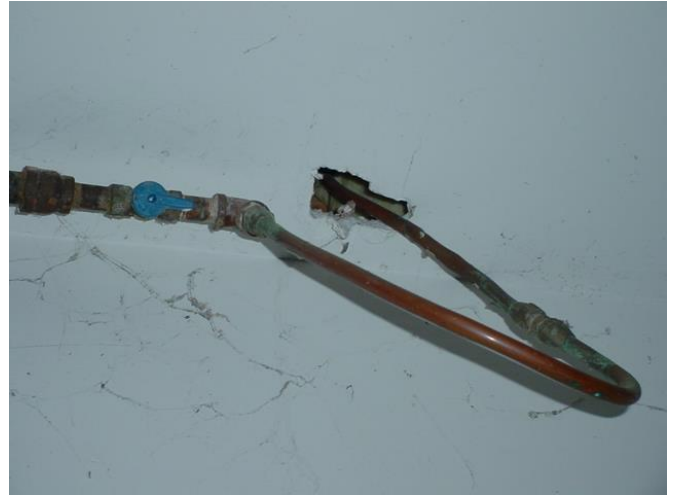
- **Repair:** There is a hole in the garage ceiling at the fireplace gas pipe. The hole should be sealed to restore the fire-and-fume barrier between the garage and the residence.

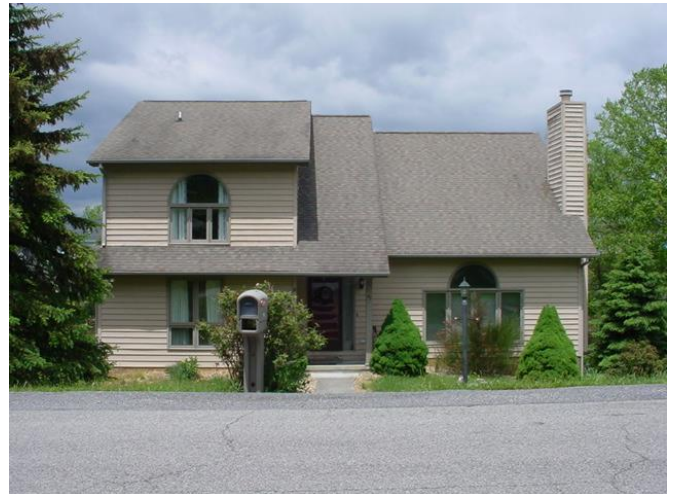
- The dark stains on the shingles are caused by the growth of algae, and are common on north-facing shingles in this region. The stains are a cosmetic concern only.

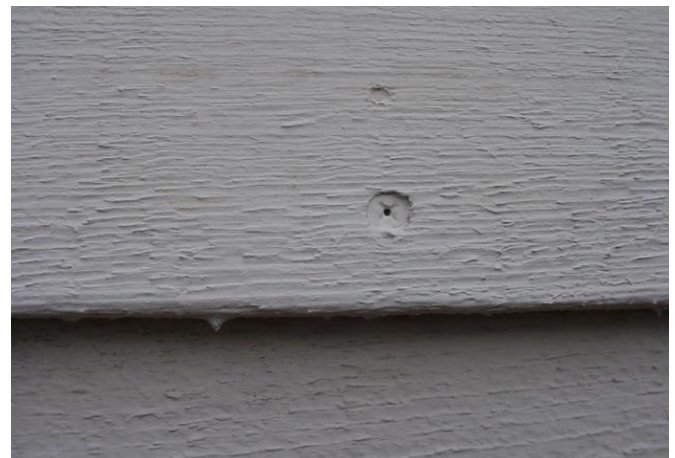
- The wood siding is worn and cracked, particularly on the west exposure. Several cupped laps have been drawn back against the wall with screws. Keep gaps and cracks in the siding filled to minimize water penetration into the walls.

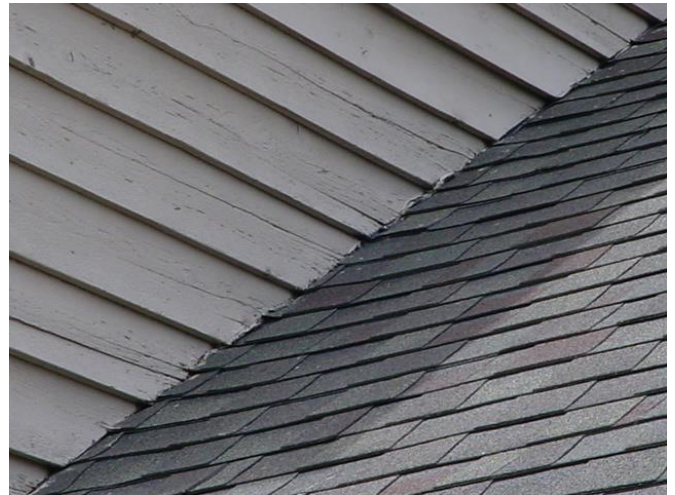
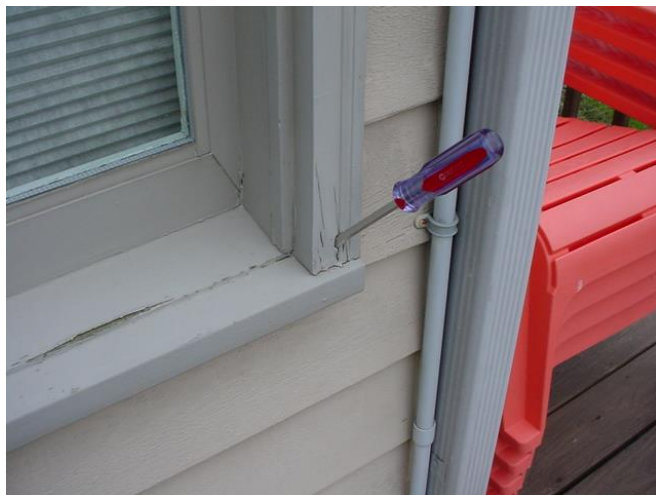
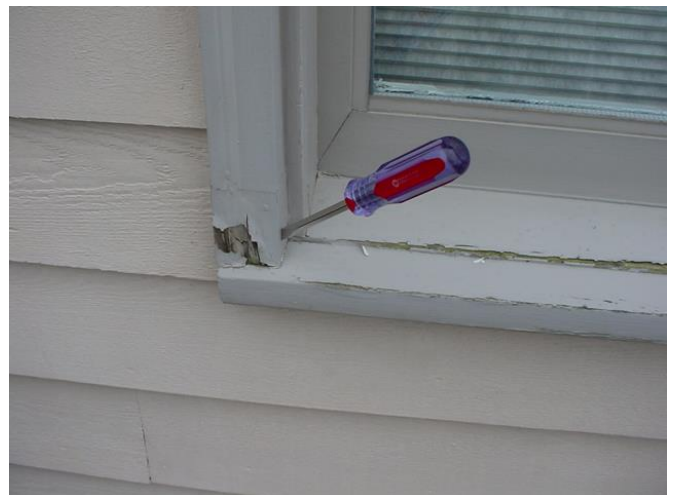
- **Improve:** Sections of the wood siding are in contact with the asphalt shingles on the roof. There should be a capillary break of 1-inch or more between shingles and wood siding to keep the wood from wicking moisture when the shingles are wet.

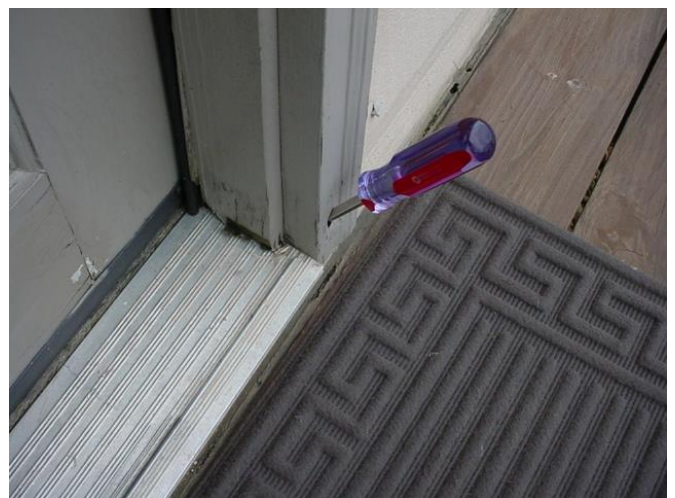
- **Repair:** Several sections of wood trimwork have been damaged by decay.

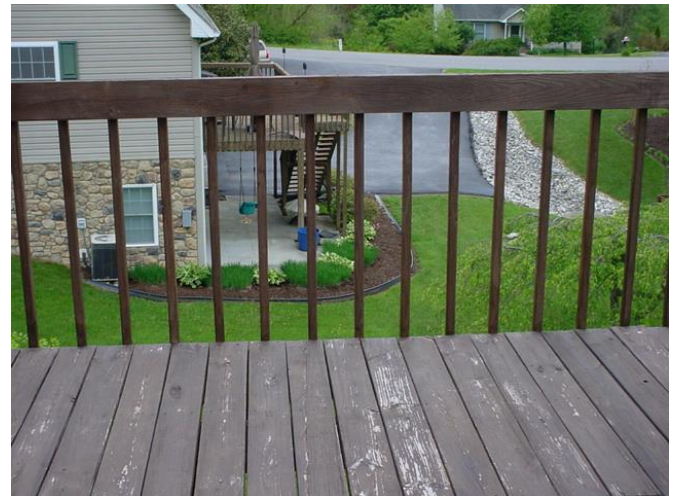
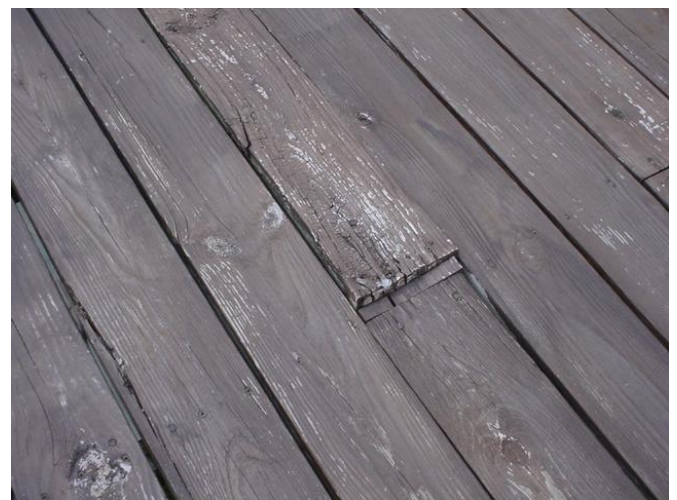
- **Safety Issue:** The steps in the deck stairway are only 8-1/2 inches deep. Treads that are less than 9 inches deep are tripping hazards.
- **Safety Issue:** The bottom step in the deck stairway is short. Steps in a stairway that vary in height more than 3/8-inch are tripping hazards.
- **Safety Issue:** The risers in the deck stairway are open. To prevent entrapment, the openings in a stairway should be no more than 4 inches wide.
- **Safety Issue:** Openings in the deck stairway guards are 5-3/4 inches wide. Guards on open sides of stairways, raised floor areas, balconies and porches should have intermediate rails or ornamental closures that do not allow passage of an object 4 inches or more in diameter.
- Sections of the decking are worn.

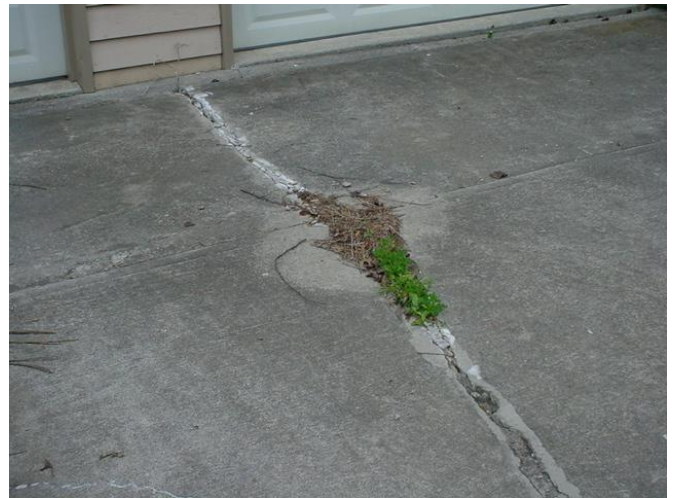
- The gap between the driveway and the apron and the cracks in the driveway are the results of settlement.

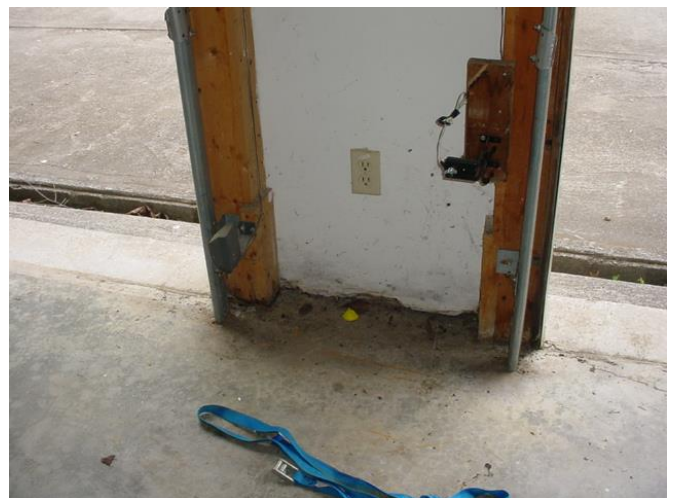
- **Safety Issue:** The photoelectric sensors that trigger the safety reverse function of the automatic garage door openers are mounted 10 inches and 20 inches above the floor. According to the Door and Access Systems Manufacturers Association Technical Data Sheet #364, the sensors should be mounted with the lens no more than 6 inches above the garage floor.
- The auto-reverse mechanisms on the overhead garage doors responded properly to testing. This safety feature should be tested regularly. Refer to the owner's manual or contact the manufacturer for more information.

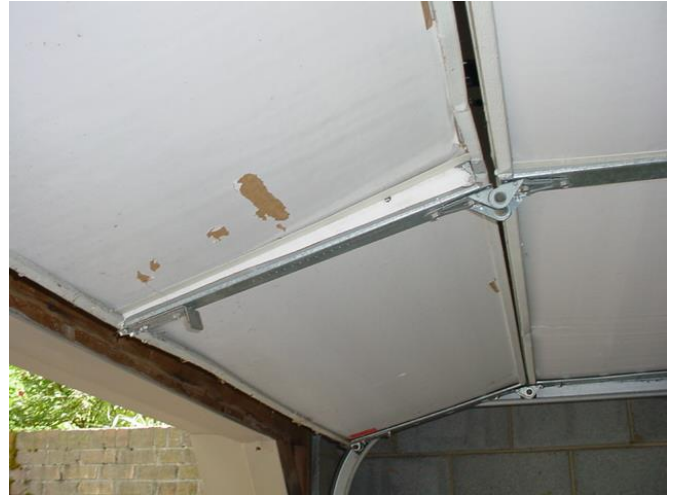
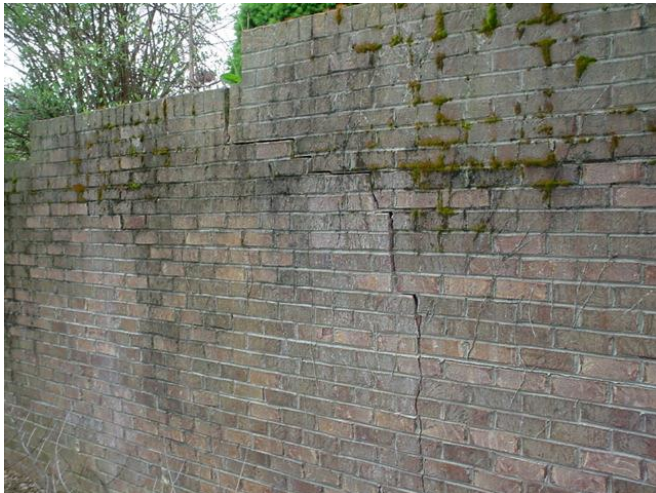
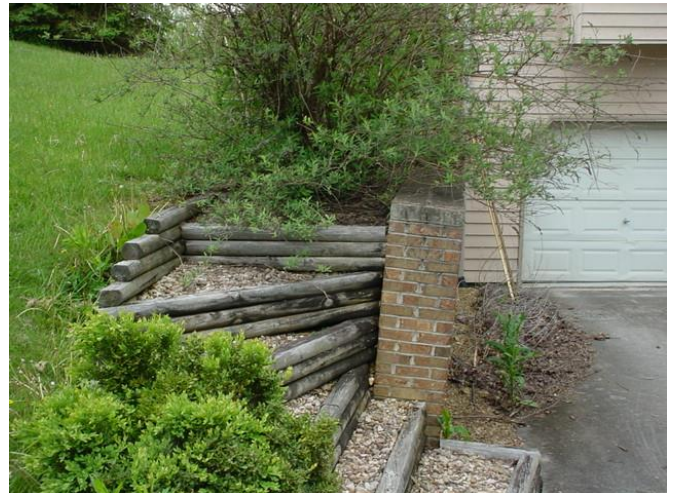
- **Repair:** The center rail has separated from the bottom panel of the front garage door.

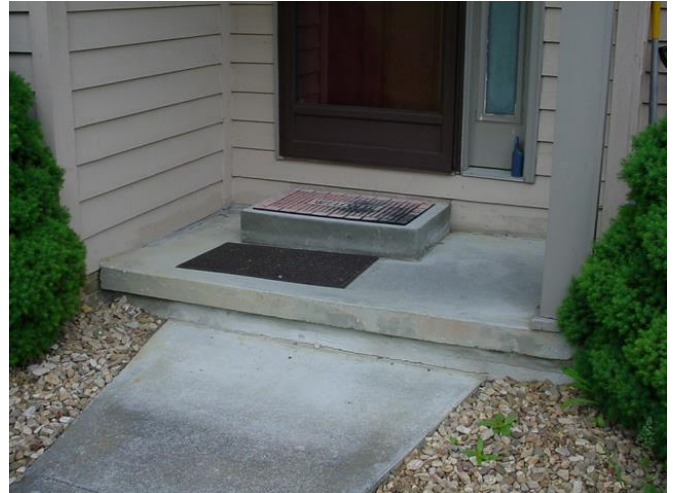
- **Repair:** The front porch slopes toward the house. The slope of the porch should direct runoff away from the house. Repair or replace the porch.
- **Safety Issue:** The landing at the front door is small. The width of the landing should be no less than the width of the doorway, and the landing should be at least 36 inches deep in the direction of travel.

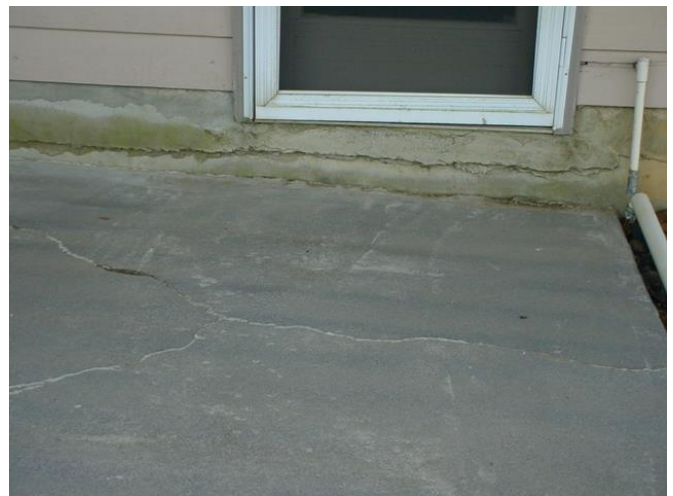
- The patio is broken and sloping, which is the result of settlement.

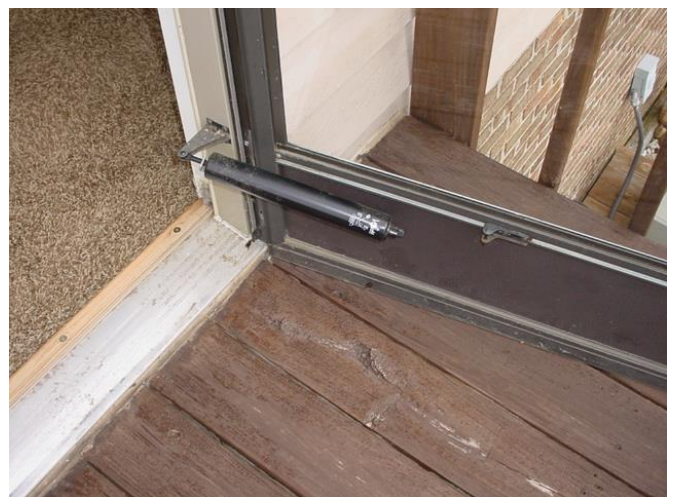
- **Improve:** There is no hydraulic closer on the storm door at the master bedroom doorway. The closer is needed to reduce the potential for wind damage to the light-weight door, which opens to the exterior.

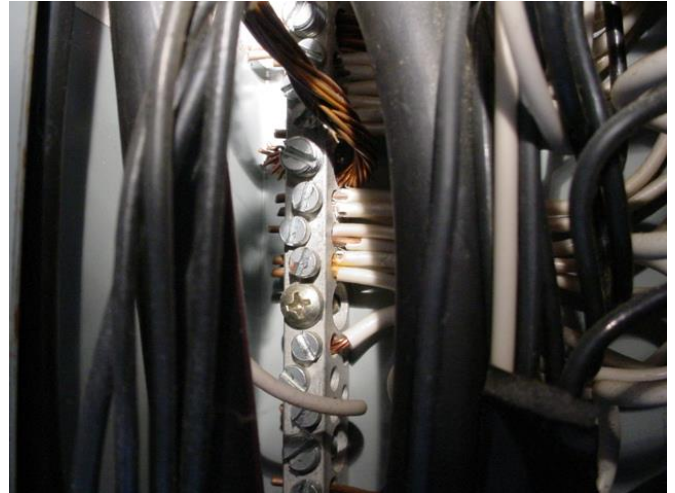
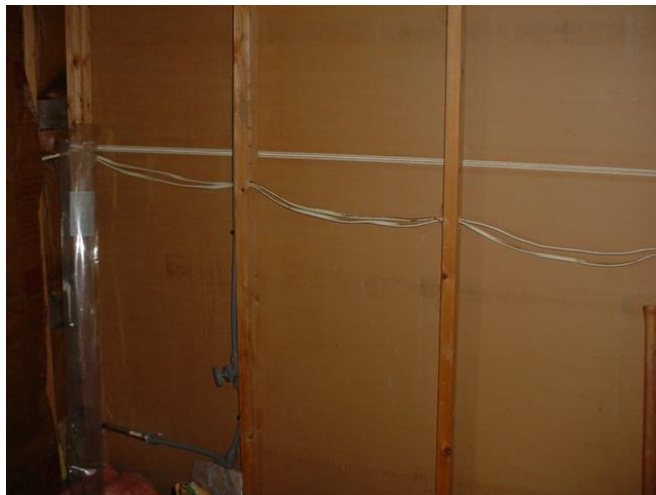
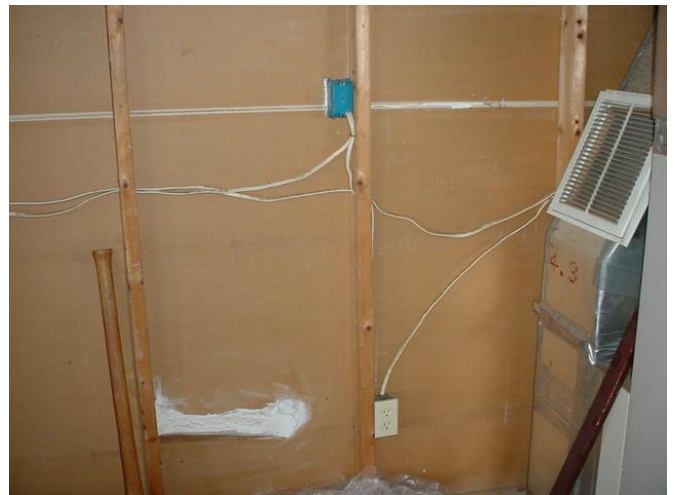
- **Safety Issue:** Multiple neutral wires are connected to several neutral bar terminals. For the most reliable wire connection that offers the least risk of overheating, each neutral wire should connect to a terminal that is not used for another conductor.

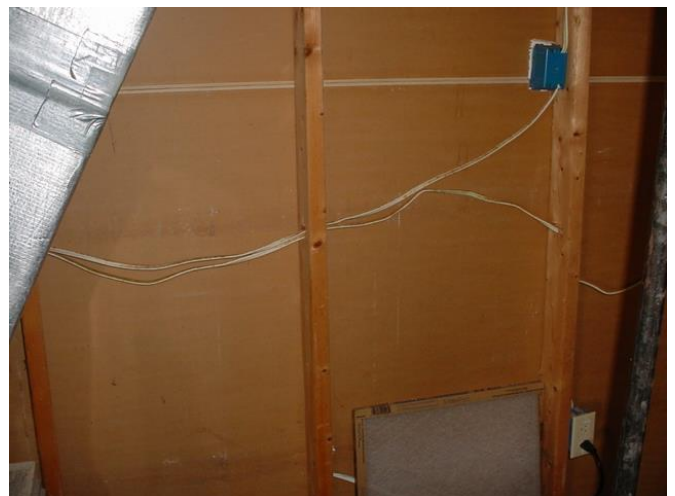
- **Safety Issue:** Electrical cables are exposed in the basement. Exposed wiring that is subject to physical damage should be adequately protected.

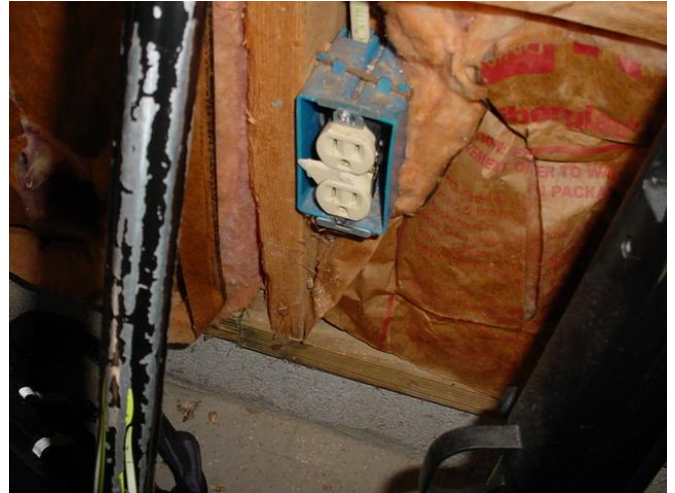
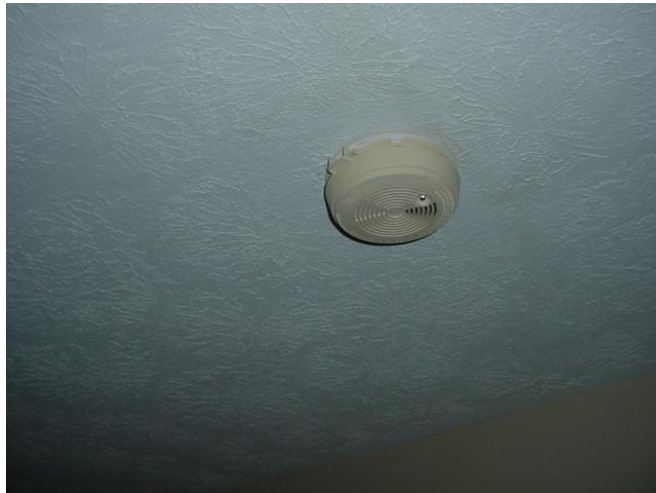
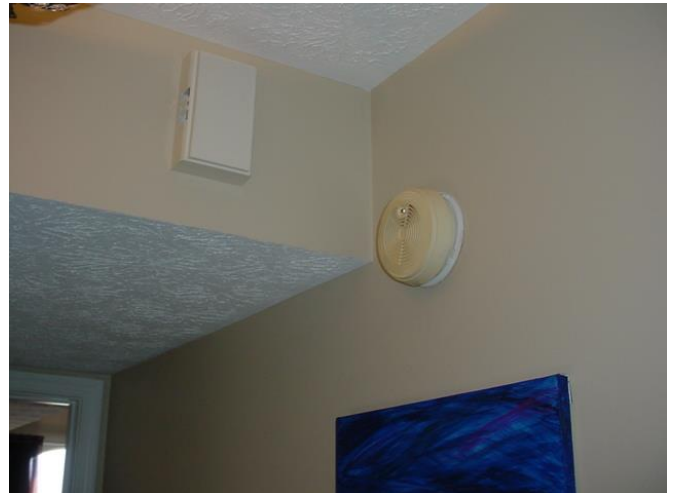
- **Safety Issue:** An outlet in the basement is uncovered. All boxes must be covered to isolate energized contacts and to contain sparks.
- **Repair: Safety Issue:** The GFCI device in the outlet at the master bedroom exterior door did not trip when tested. Rewire or replace the faulty GFCI outlet.

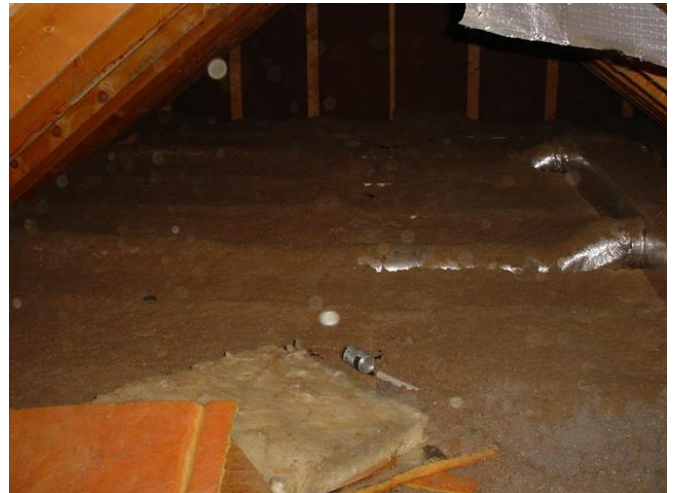
- **Improve:** Insulation improvements to R-38 are recommended.

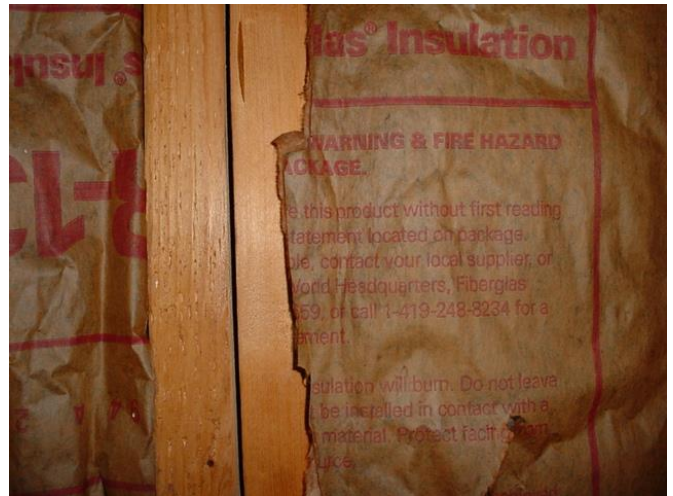
- **Repair:** Insulation in the open wood-frame walls is installed with the flammable paper facings exposed. Cover the insulation as specified in the manufacturer's printed warning to protect it from sources of ignition.

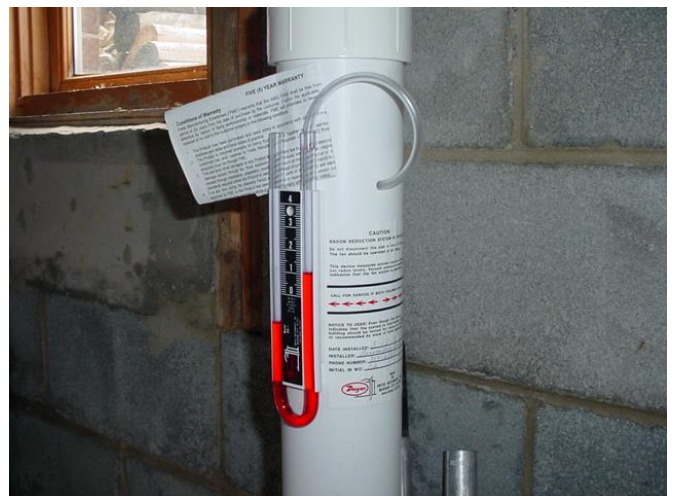
- **Monitor:** An active radon reduction system is installed in this home. The vacuum gauge (manometer) indicates the system is under negative pressure, but the gauge does not measure the effectiveness of the system. Periodic radon tests are required to determine the effectiveness of a radon reduction system.

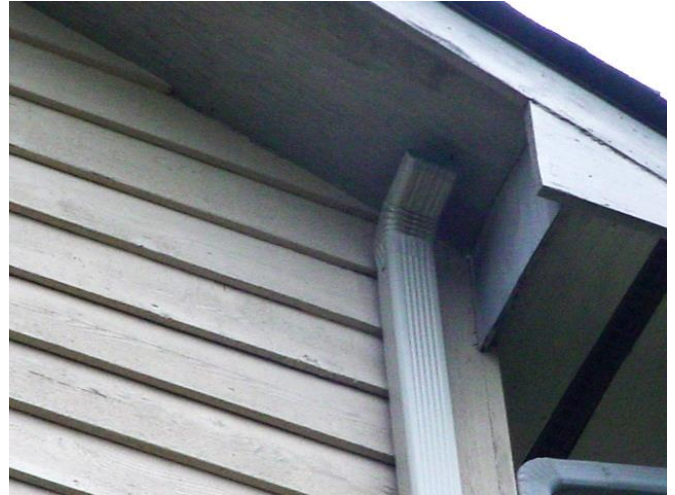
- **Improve:** The radon reduction system vent stack terminates against the soffit at the south roof overhang. To avoid staining the wood and deflecting the system exhaust back toward the house, the vent stack should extend above the roof.

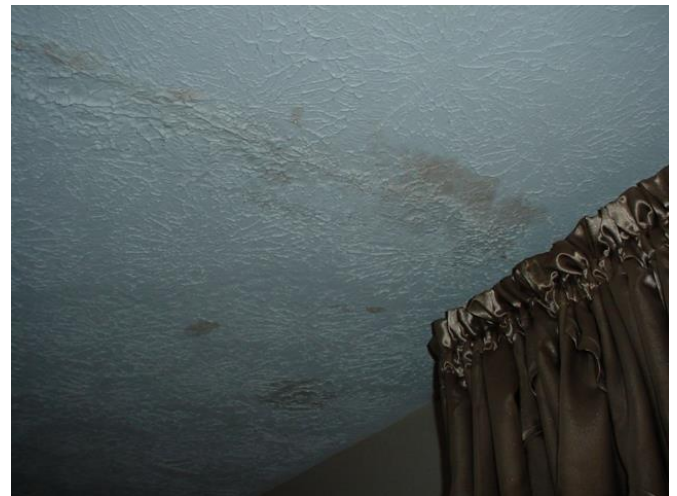
- The master bedroom ceiling is stained and cracked. No evidence of recent water contact was detected.

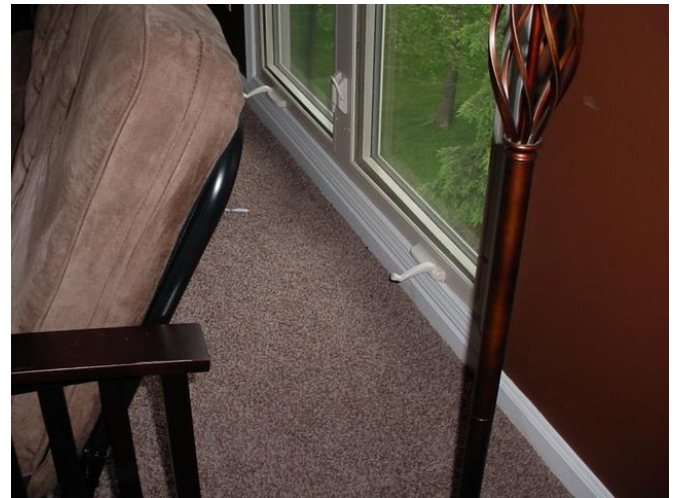
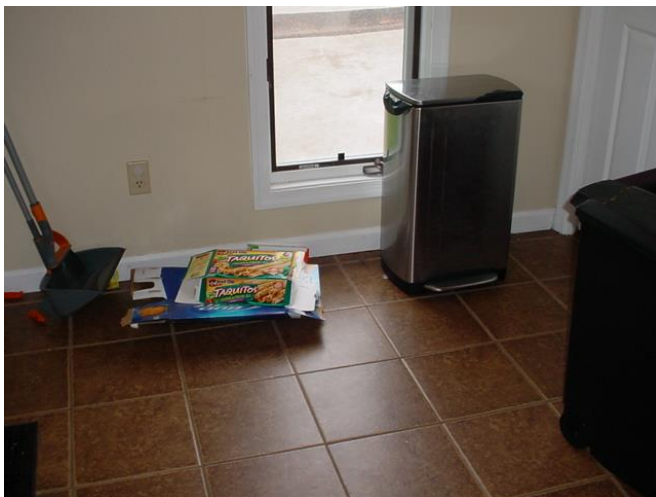
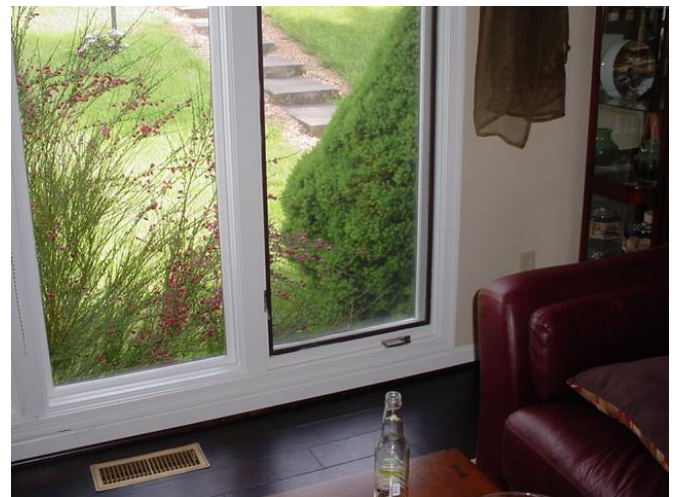
- **Safety Issue:** The window sills in several rooms are only 12 inches above the floor, which is a fall hazard. The sill of an operable window that is more than 72 inches above grade should be at least 18 inches above the floor. For effective fall protection at these windows, the installation of an approved window guard is recommended. Since the bedroom windows provide emergency egress, any installed guard must be removable without tools or special knowledge.
- **Repair:** Several window sashes are obstructed by the metal cladding that was installed over the exterior casings. Repair as needed to allow the sashes to open and close properly.

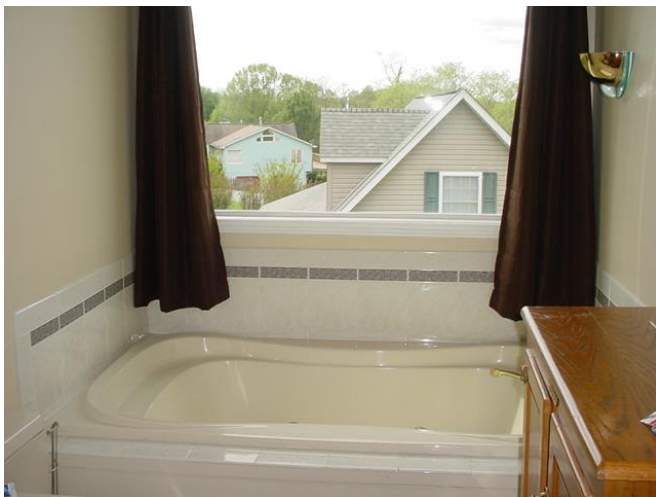
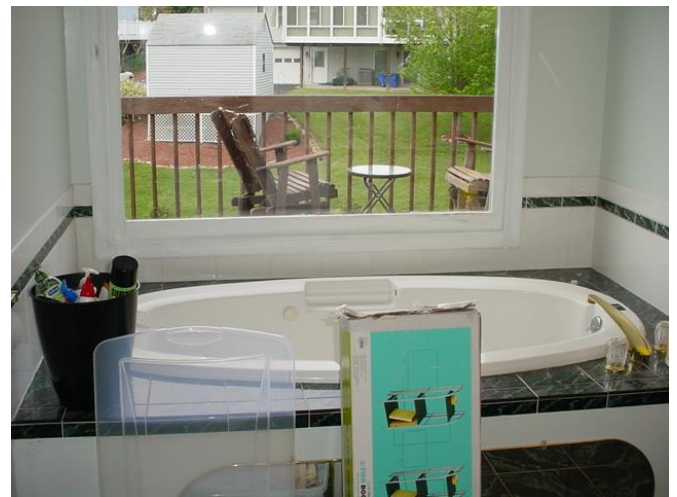
- Moisture has condensed in the space between panes in several windows. This failure of the seal between the panes can affect the insulating value and the clarity of the windows.

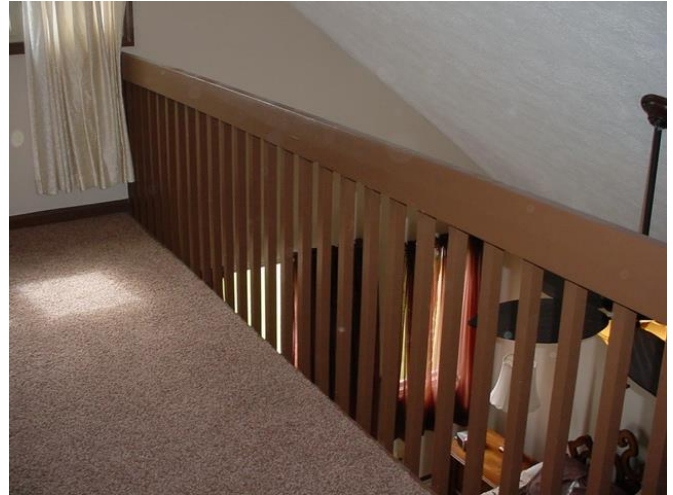
- **Improve: Safety Issue:** The loft guard deflects when force is applied. Reinforce as needed to allow the guardrail to resist a single concentrated load of 200 pounds applied in any direction at any point along the top rail.
