# Building Analysis Report

## Christiansburg, VA

Inspection Date:  
**5/6/2016**

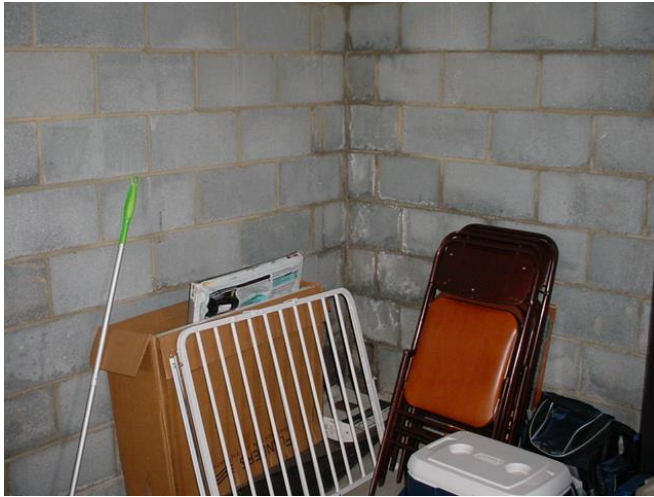
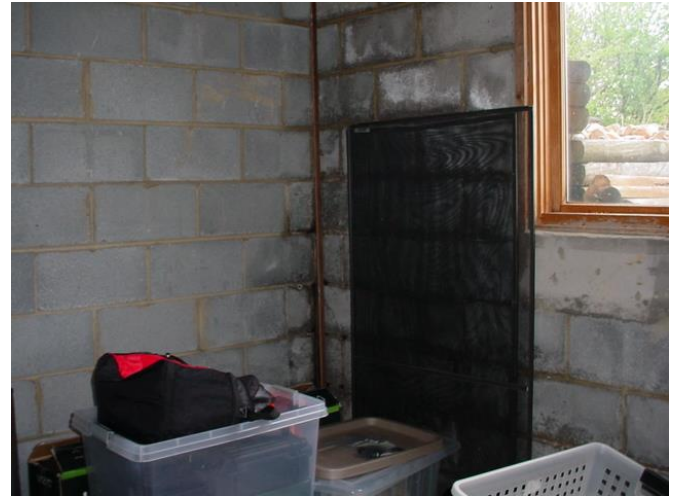
- **Improve:** Stains and efflorescence on the front wall are the results of the penetration of surface runoff. Evidence of water penetration in underground spaces typically indicates a need for exterior drainage improvements.

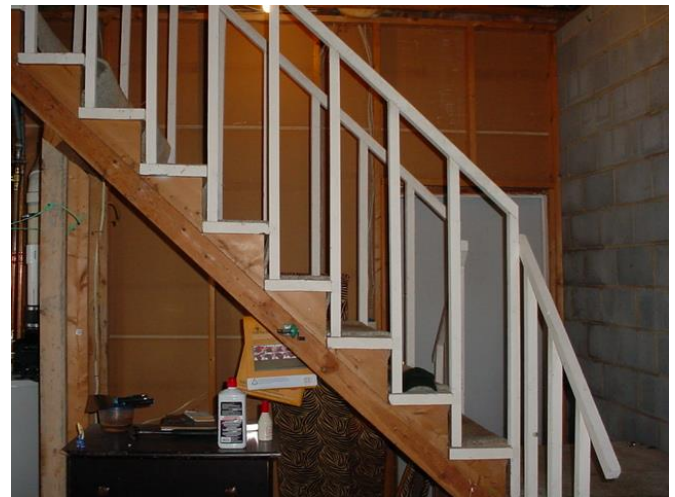
- **Safety Issue:** Openings in the basement stairway guard are 7 inches wide. Guards on open sides of stairways, raised floor areas, balconies and porches should have intermediate rails or ornamental closures that do not allow passage of an object 4 inches or more in diameter.

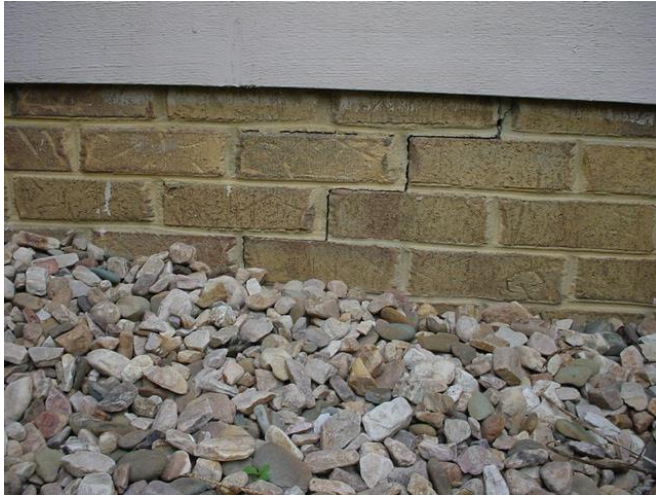
- An offset vertical crack in the front foundation wall is typical of settlement and lateral pressure exerted by saturated expansive soil. The crack has been patched. Reinforcement of the wall may be needed if movement continues.

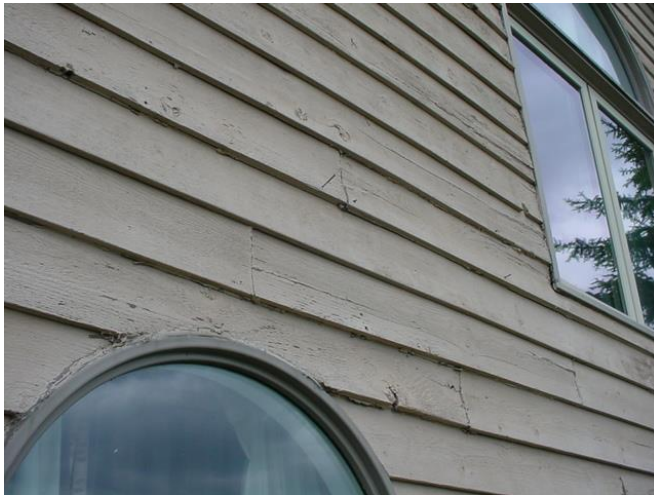
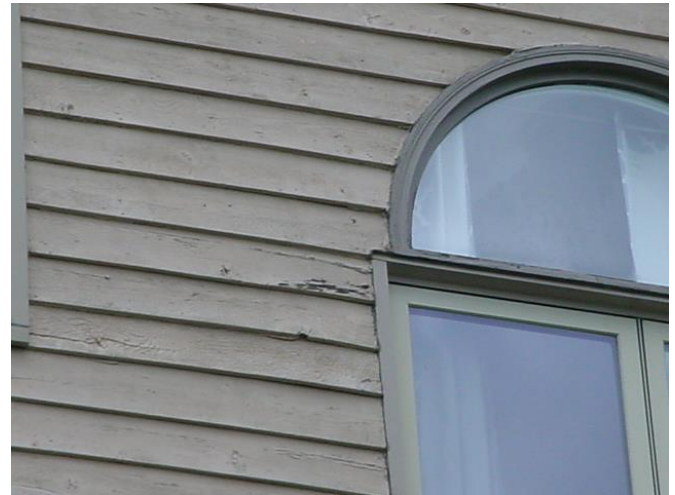
- The wood siding is worn and cracked, particularly on the west exposure. Several cupped laps have been drawn back against the wall with screws. Keep gaps and cracks in the siding filled to minimize water penetration into the walls.

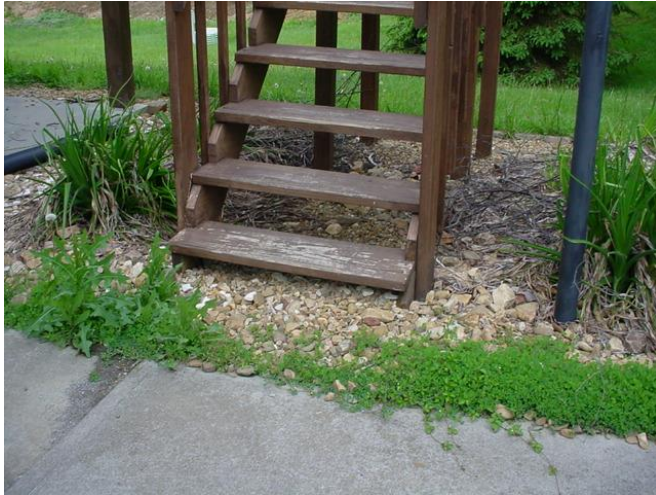
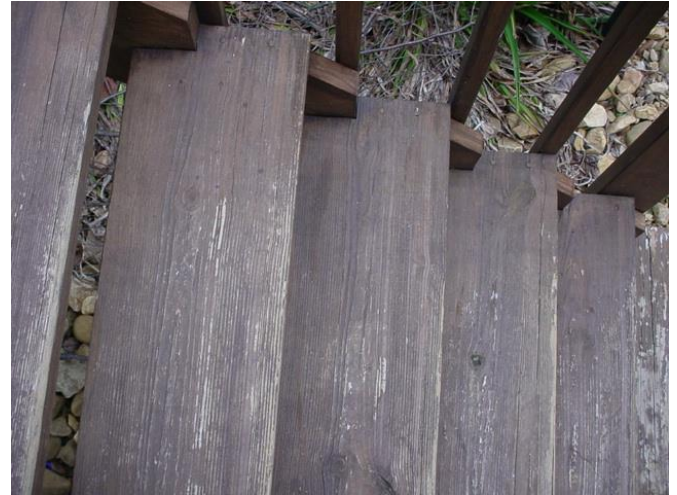
- **Safety Issue:** The steps in the deck stairway are only 8-1/2 inches deep. Treads that are less than 9 inches deep are tripping hazards.
- **Safety Issue:** The bottom step in the deck stairway is short. Steps in a stairway that vary in height more than 3/8-inch are tripping hazards.
- **Safety Issue:** The risers in the deck stairway are open. To prevent entrapment, the openings in a stairway should be no more than 4 inches wide.
- **Safety Issue:** Openings in the deck stairway guards are 5-3/4 inches wide. Guards on open sides of stairways, raised floor areas, balconies and porches should have intermediate rails or ornamental closures that do not allow passage of an object 4 inches or more in diameter.
- Sections of the decking are worn.

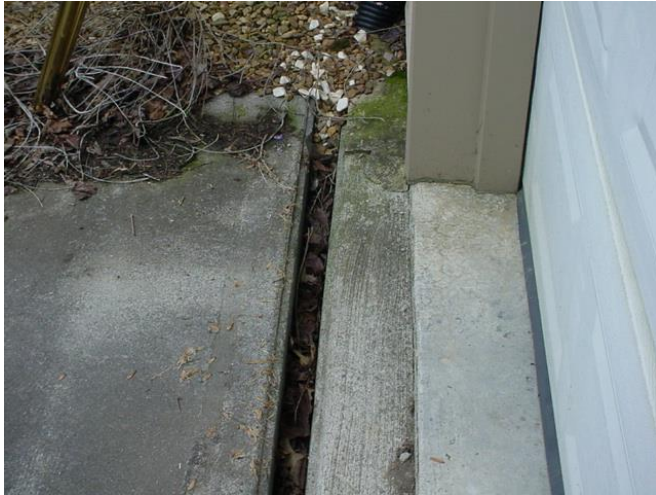
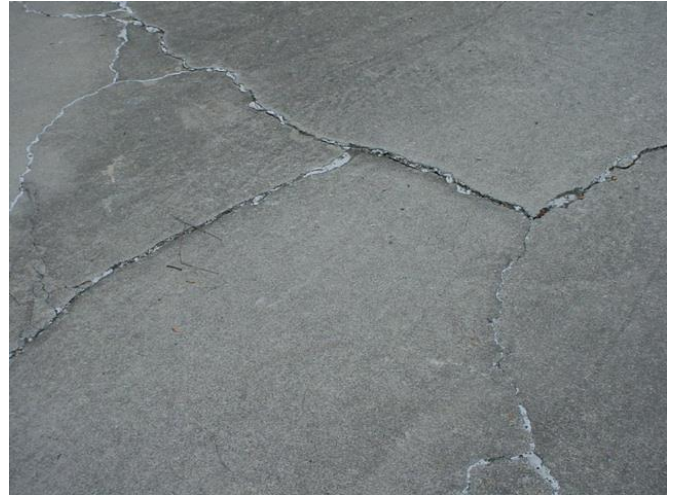
- The gap between the driveway and the apron and the cracks in the driveway are the results of settlement.

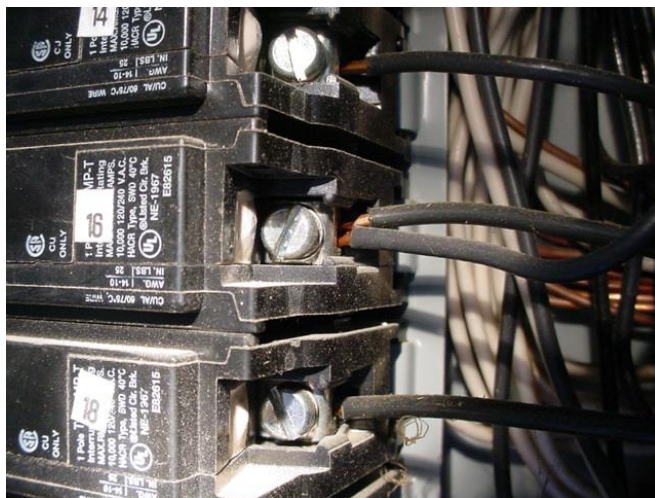
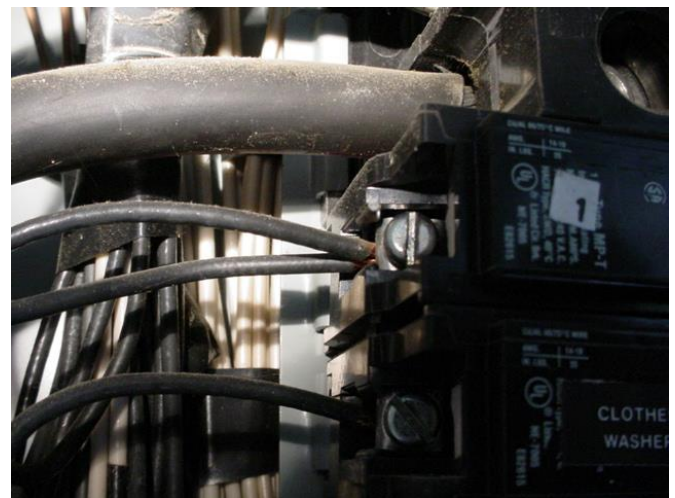
- **Safety Issue:** Two breakers have two wires connected to terminals that were designed to secure one wire only. These “double-tap” connections are not as safe and reliable as the single-wire connection that is intended for each terminal.
- **Improve:** A low-voltage transformer is located in the panelbox. Low-voltage wiring and transformers should not be located in an enclosure with line-voltage circuits.

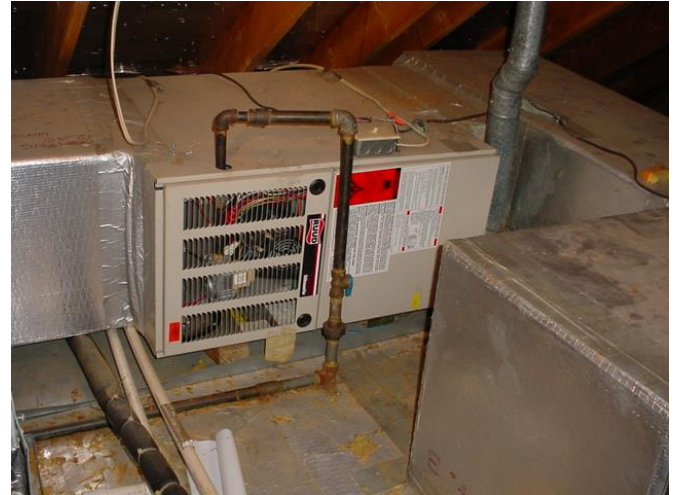
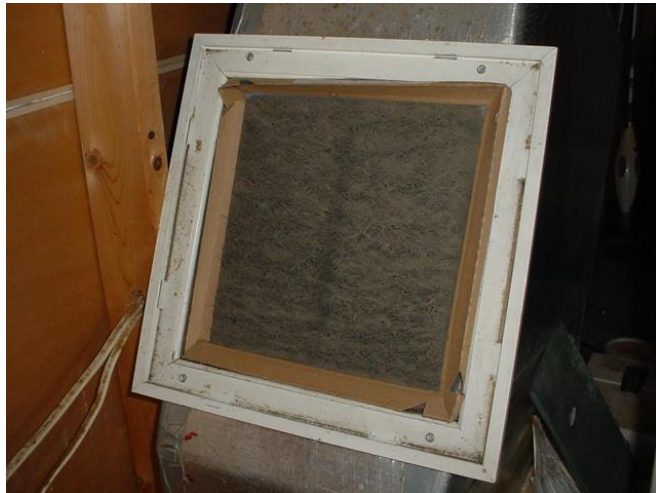
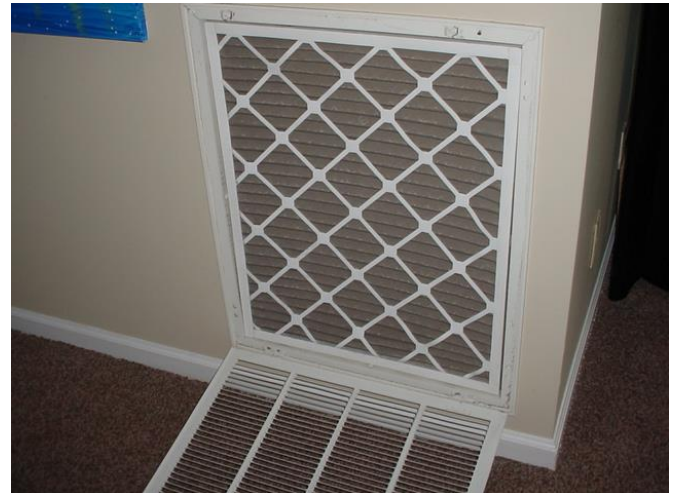
- **Repair:** The air filters are dirty. Replace the filters to improve air quality and flow.

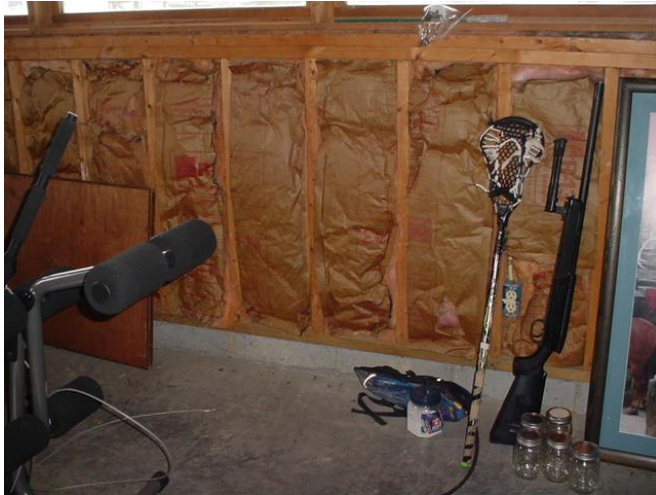
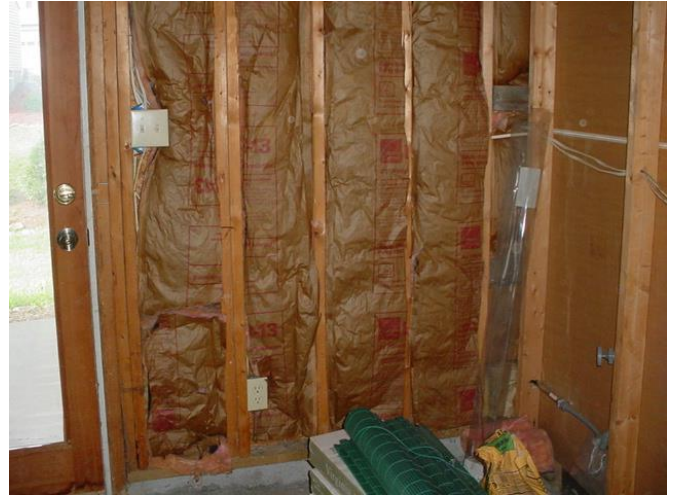
- **Repair:** Insulation in the open wood-frame basement wall is installed with the flammable paper facings exposed. Cover the insulation as specified in the manufacturer's printed warning to protect it from sources of ignition.

- **Repair:** Insulation in the open wood-frame walls is installed with the flammable paper facings exposed. Cover the insulation as specified in the manufacturer's printed warning to protect it from sources of ignition.

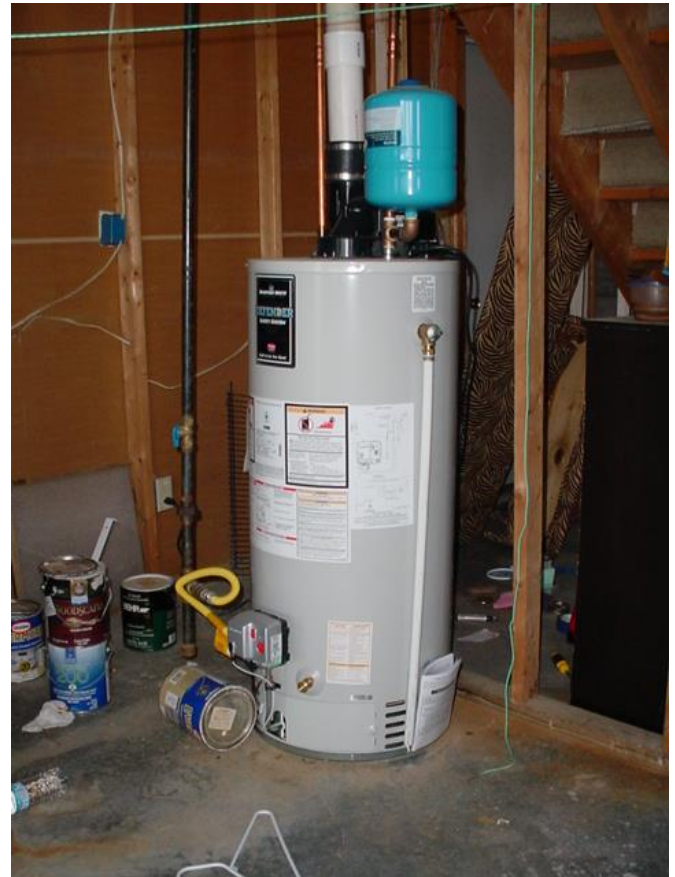
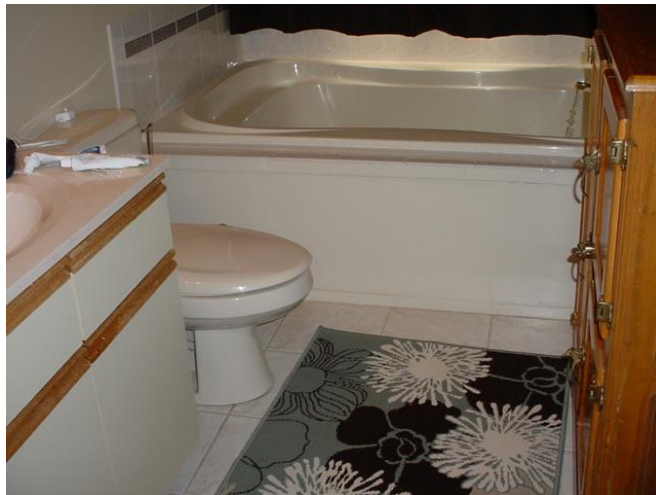
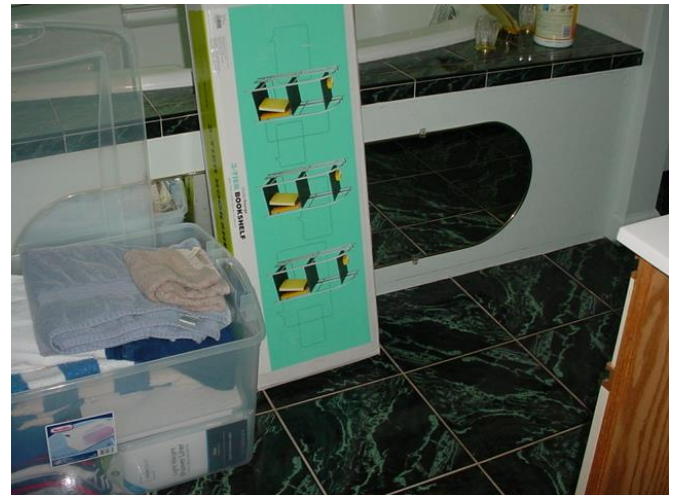
- **Repair:** No access was found to the pump/motor under either of the whirlpool bathtubs. Access is necessary to allow inspection and repair of the mechanical equipment. Provide a means of access that meets the installation specifications of the whirlpool bathtub manufacturer.

- **Repair:** No access was found to the pump/motor under either of the whirlpool bathtubs. Access is necessary to allow inspection and repair of the mechanical equipment. Provide a means of access that meets the installation specifications of the whirlpool bathtub manufacturer.
- **Safety Issue:** Debris discharged from the jets when the upstairs whirlpool bathtub was tested. Clean and disinfect the whirlpool bathtub according to the manufacturer's instructions.

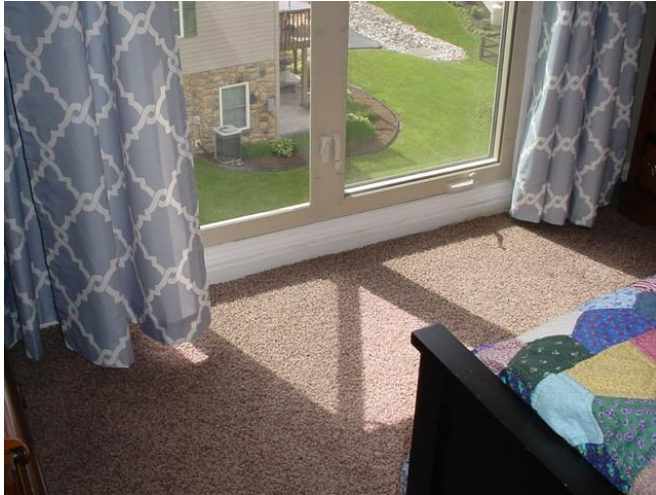
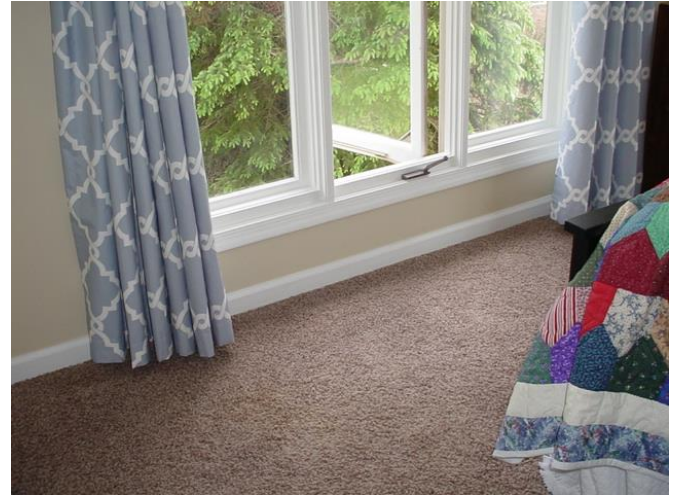
- **Safety Issue:** The window sills in several rooms are only 12 inches above the floor, which is a fall hazard. The sill of an operable window that is more than 72 inches above grade should be at least 18 inches above the floor. For effective fall protection at these windows, the installation of an approved window guard is recommended. Since the bedroom windows provide emergency egress, any installed guard must be removable without tools or special knowledge.

- **Repair:** Several window sashes are obstructed by the metal cladding that was installed over the exterior casings. Repair as needed to allow the sashes to open and close properly.

- **Safety Issue:** The window sills in several rooms are only 12 inches above the floor, which is a fall hazard. The sill of an operable window that is more than 72 inches above grade should be at least 18 inches above the floor. For effective fall protection at these windows, the installation of an approved window guard is recommended. Since the bedroom windows provide emergency egress, any installed guard must be removable without tools or special knowledge.
- **Repair:** Several window sashes are obstructed by the metal cladding that was installed over the exterior casings. Repair as needed to allow the sashes to open and close properly.

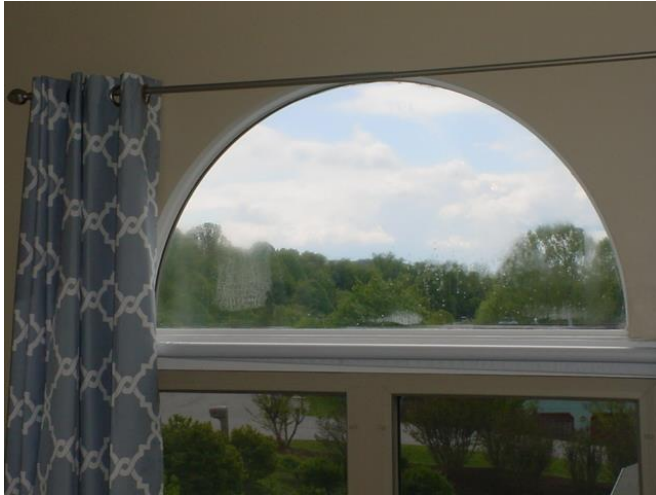
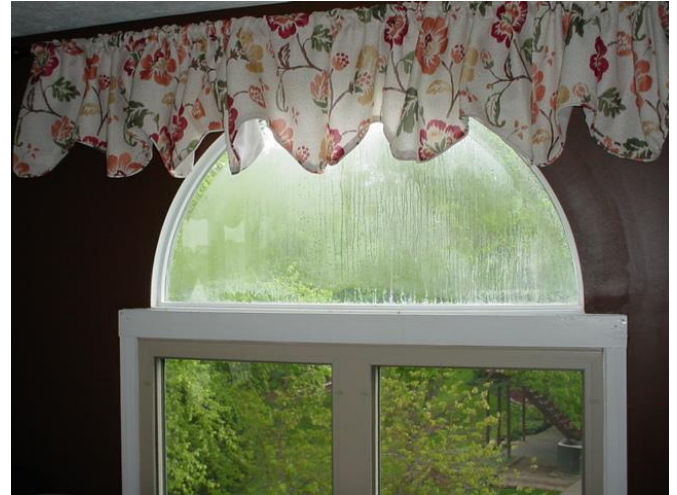
- Moisture has condensed in the space between panes in several windows. This failure of the seal between the panes can affect the insulating value and the clarity of the windows.

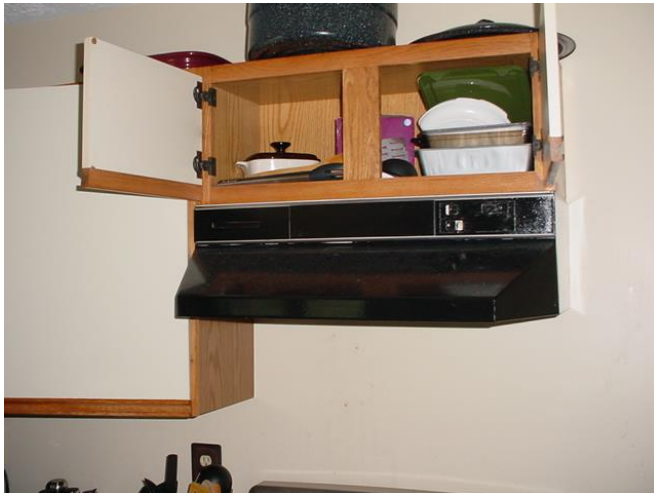
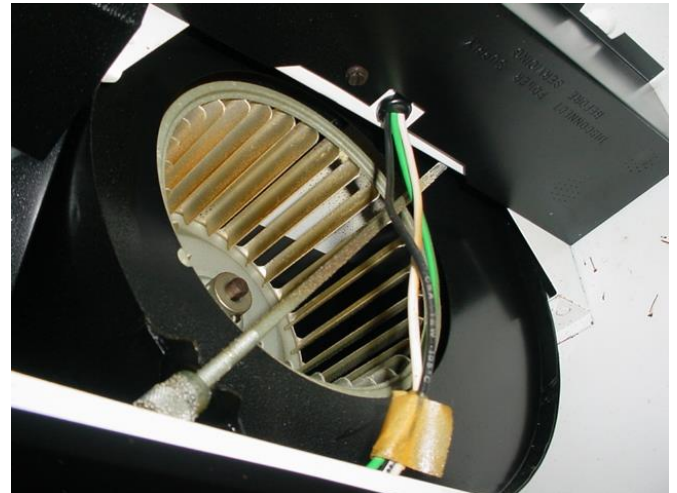
- **Repair:** The blower exhaust port is obstructed by the hood, which prevents air from circulating. Modify the installation to meet the manufacturer's specifications, which will allow air to flow back into the house or outdoors.

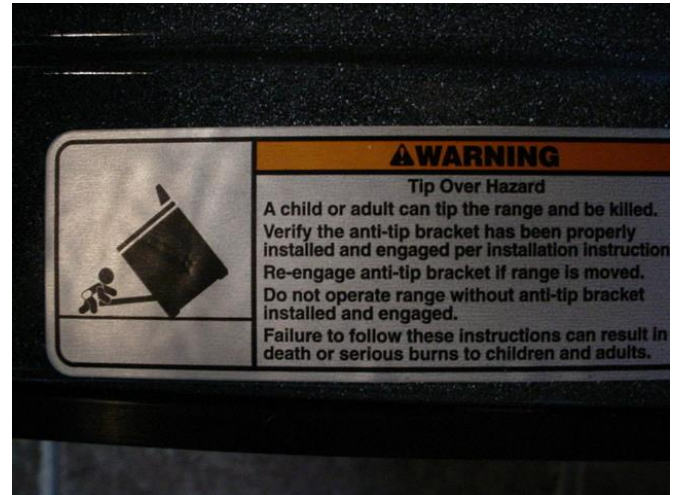
- **Safety Issue:** The label attached to the oven door specifies the installation an anti-tip bracket, because the range is unstable when the oven door is open. Install the bracket to prevent the range from tipping.
